Assessment of the Current Status of Irrigation Activity and Drainage Infrastructure in Iraq

SUMMARY

This technical report assesses the current state of the irrigation and drainage in the Babil and Wasit provinces in central Iraq. It describes and documents the irrigation activity and drainage infrastructure in two selected irrigation projects for this pilot study. The report also refers to the causes that led to increase salinity and land degradation in these areas.

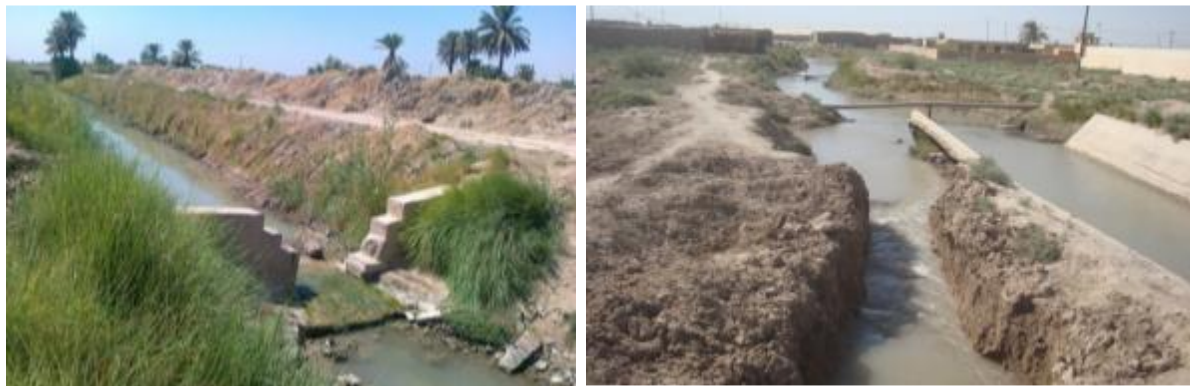
Figure 2: State of existing infrastructure at the project sites.

The assessment of current status of the two project areas has been done at two scales for each project (Figure 2). The first level of assessment (which covers the entire area) studies main canals, branch, cross regulators, head regulators, main drains, branch drains, secondary drains, and pumping stations. The second level of assessment studies feeder canals, farm intakes, field drains, collector drains, and open drains. This also includes irrigation and drainage water sampling on-farm practices and water-use efficiency. Figure 4 shows the existing condition of two irrigation channels in Great Mussaib and Dujaila respectively. This is an illustration of the general state of irrigation and drainage infrastructure within the two sites.

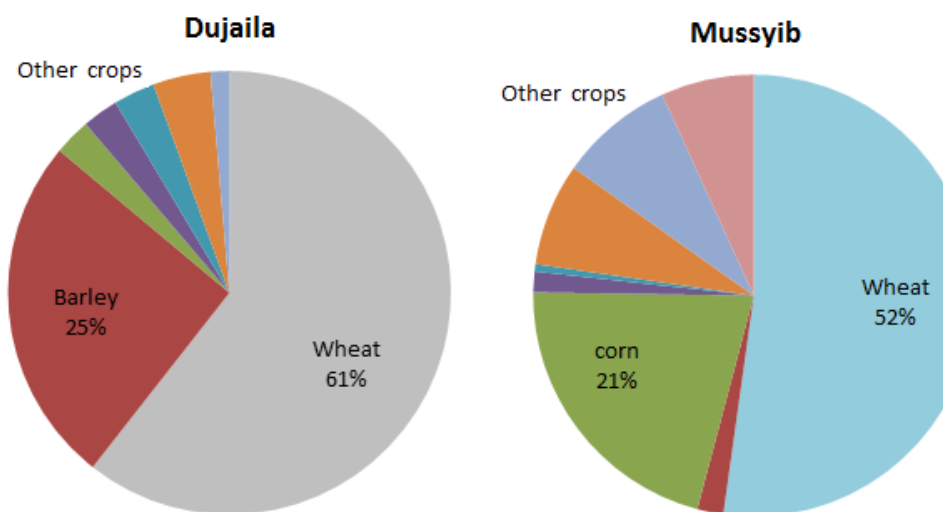
In **Mussaib**, wheat in winter and corn in summer represent the main cropping pattern in the project area in addition to other crops like barley, alfalfa, clover, and different vegetables in winter and white maize, cotton, sunflower, sesame, chickpeas, alfalfa, clover and different vegetables in summer (Figure3).

Figure 3: Wheat and barley are the major crops in Dujaila and Mussayib projects. Charts show the percentage of project area used for cultivation of various crops, based on average area cultivated between 2006 and 2010 (Data source: Ministry of Agriculture).

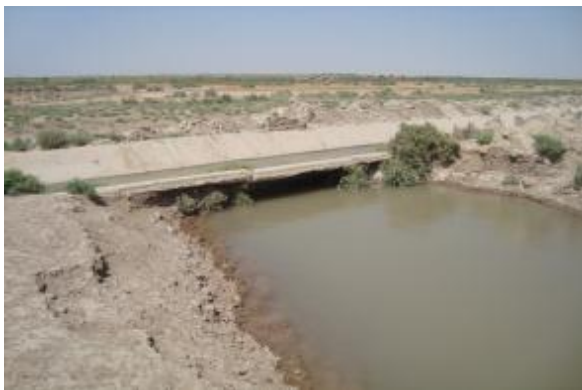
Figure 4: Damaged concrete lining.

Concrete lining in many parts of the concrete lined canals have been damaged or collapsed, as shown in Figure4. In addition, the lack of maintenance for the expansion joints with tar materials is causing seepage and water losses.

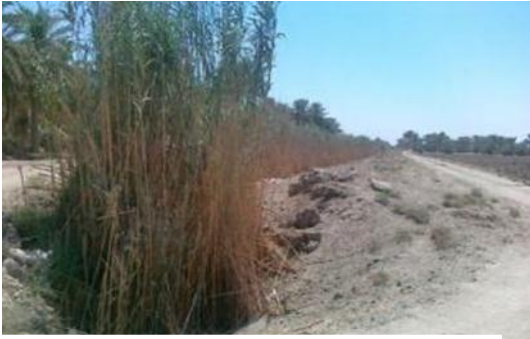
Most of the open field drains and collector drains are not cleaned and maintained as shown in Figure 8, as these are private benefit and the responsibility lies on the beneficiary farmers. Consequently these drains have low efficiency causing drainage network deficiency and ground water table increase which contribute to the salinity problem.

Figure 5: Wild growth in drainage channels at Mussaib

In addition to that, the distance between field drains of 330 m is too much and requires redesign of the field drains network according to the soil characteristics and conditions as well as the irrigation water quality at the current time. In some parts of the project closed field drains were built with the spacing of 70 - 100 m and depths between 2 - 2.4 m. Total length of these drains was 379 km. However, they are now misused.

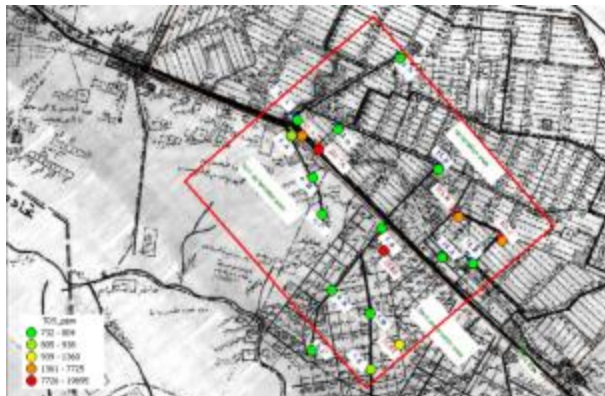
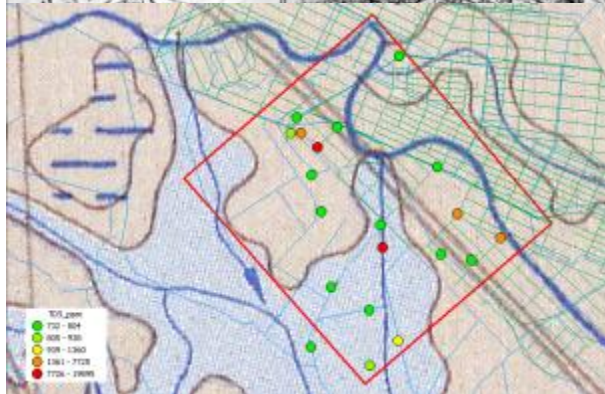
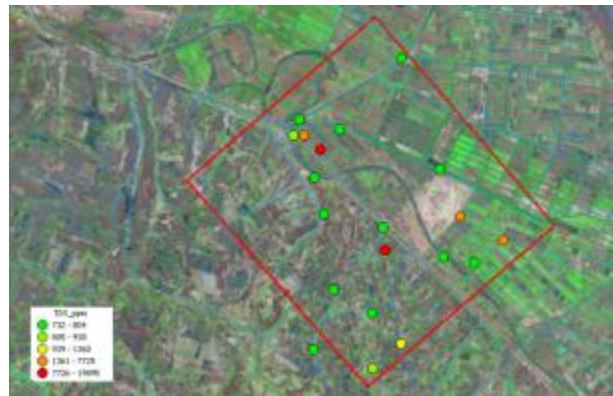
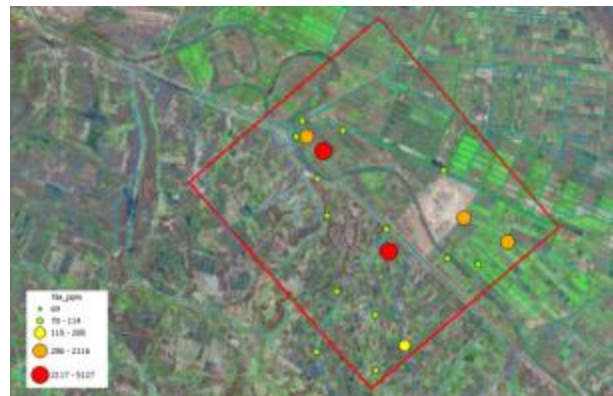
Figure 6: TDS and Na concentration of canal water in Dujaila (Water quality data source: Field sampling by project team)

The range of irrigation water quality across the project during summer season 2011 was between 1.11-1.32 dS/m with average 1.16 dS/m. Figure6 shows TDS and Na concentration data (surface water sampling) for Dujaila project. While there seems no particular spatial pattern of TDS concentration with respect to surface features or geology of the region, there seems strong correlation between TDS and Na concentrations, suggesting that Na is the dominant ion in irrigation water from canals in the area. Recent surface water quality data was only available for Dujaila

Surface water TDS overlay on geological map

Surface water TDS overlay on aerial photo

Surface water Na concentration overlay on aerial photo
