Investment plan

Rehabilitation of irrigation and drainage infrastructure in Iraq

**A contribution from Component D of the
Soil Salinity Management in Central and Southern Project**

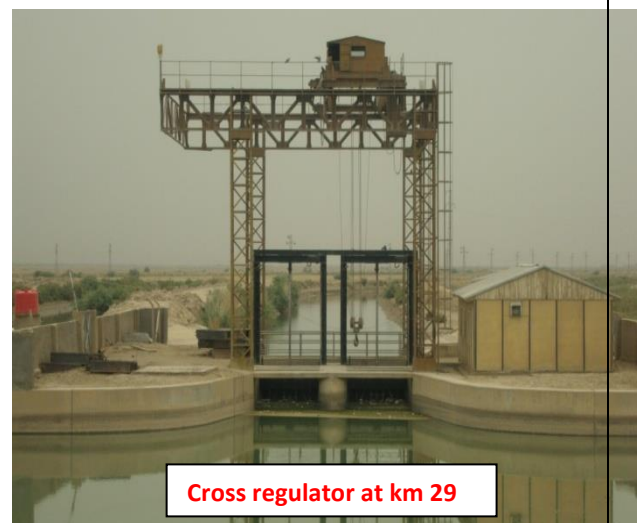
Five branch canals are located within the semi reclaimed area with total length of 83 km and total discharge of 12.45 m³/s while other six canals are feeding the non-reclaimed area with a total length of 72.5 km and total discharge of 11.1 m³/s. On both sides of Dujaila main canal, there are 54 small canals belonging to the private farmers with each having a discharge capacity of less than 400 l/s. On the main canal there are 5 cross regulators located at the distances of 16, 29, 36, 45, and 51 km from the canal head to control water levels and discharges in the branch canals (see Figure 2).

Figure 2: Irrigation network at the Al-Dujaila project area with a cross regulator at 29 km.

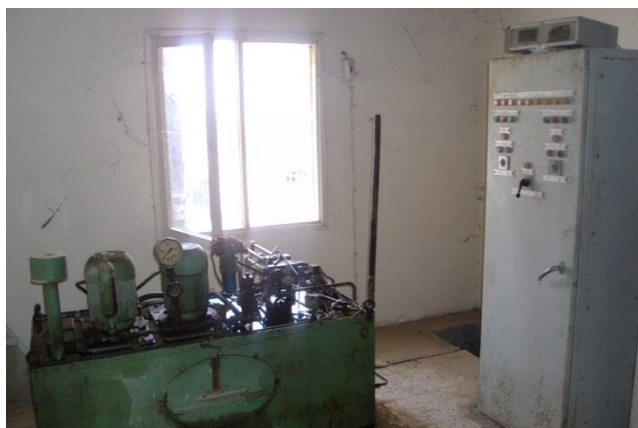
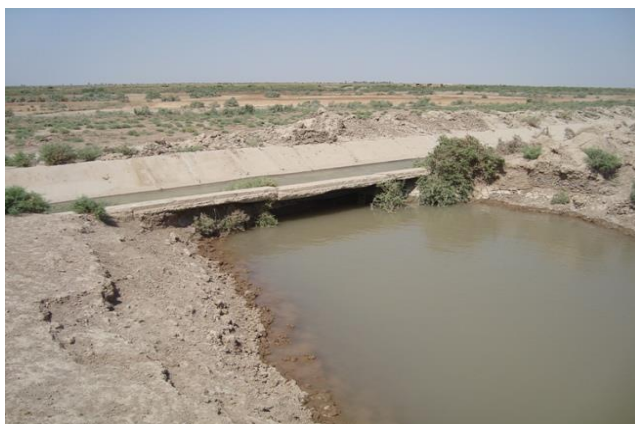
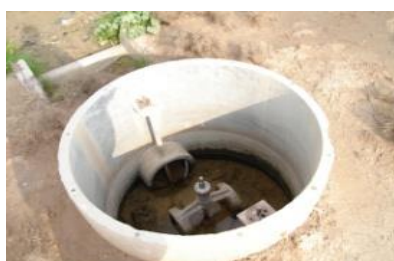
In the semi-reclaimed and non-reclaimed areas, cross regulators on main canal are old and have deteriorated over time and needs extensive repair. The irrigation canals in these areas (public or private benefit) are unlined and have lost their carrying capacity due to continuous negligence. Flows in these canals are badly restricted because of weeds, plants growth, and deposition of sediments. Over the past many years, these canals were continuously cleaned using hydraulic excavators and other heavy machinery. As a result, these canals have lost their design cross sectional dimensions and these channels have become many times larger than their designed dimensions. This has resulted in huge water losses through seepage leading to increased groundwater levels.

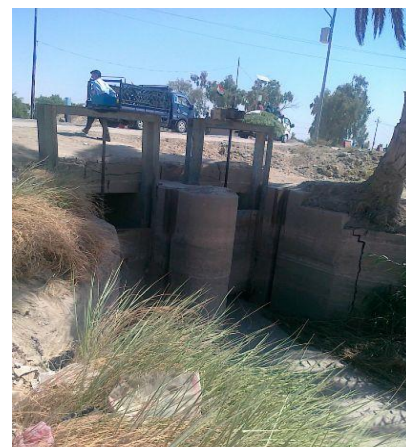
The irrigation network of the project is composed of unlined canals. These canals have lost their design cross sections and carrying capacity due to continuous negligence of maintenance. This has increased the irrigation water losses through seepage, causing high ground water levels. Moreover, these new cross sectional dimensions have caused decrease in irrigation water levels at the farm intakes and weirs. This has prompted farmers to lower their farm intakes and weir levels and install water pumps directly on the canals. The beneficiaries from these distributaries changed these structure levels in order to pass the water to their canals because the structure level is higher than the irrigation water levels upstream.

Despite some maintenance on the irrigation structures (public benefit structures) every year, all of these structures and the private benefit structures are in bad shape due to age and poor maintenance. Many of them have completed their lifespan and needs intensive rehabilitation which requires additional financial allocations to execute required rehabilitation work. Table 12 shows a summary of the current status and efficiency of the existing irrigation infrastructure.

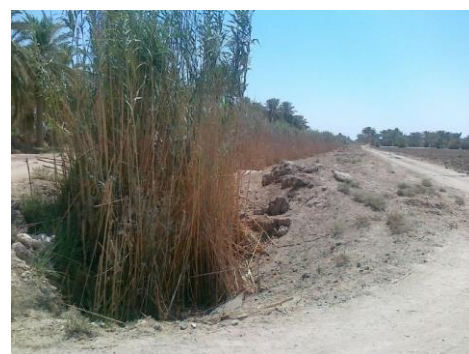
Most of the open field drains and collector drains are not cleaned and maintained because they are private property and the responsibility lies on the beneficiary farmers. Consequently these drains have low efficiency causing groundwater table to rise which contribute to the salinity problem. The distance between field drains is 330 m which is not effective in draining the water on time. Therefore it is suggested that the network of field drains should be redesigned keeping in view

soil characteristics, cropping pattern and existing irrigation water quality. The main and secondary drains are also poorly maintained by the irrigation department. Therefore, despite this maintenance, all drainage structures (public benefit) are working with efficiency between 50-60%, while the pumping stations are rehabilitated recently and are working with good efficiency (Table 13).
