LAND DEGRADATION RISK ASSESSMENT FOR SUSTAINABLE RANGELAND RESTORATION IN JORDAN

Mira Haddad¹, Stefan Strohmeier¹, Michel Rahbeh², Sayjro Nouwakpo³, Job de Vries⁴, Osama Al-Hamdan⁵, Mark Weltz⁶

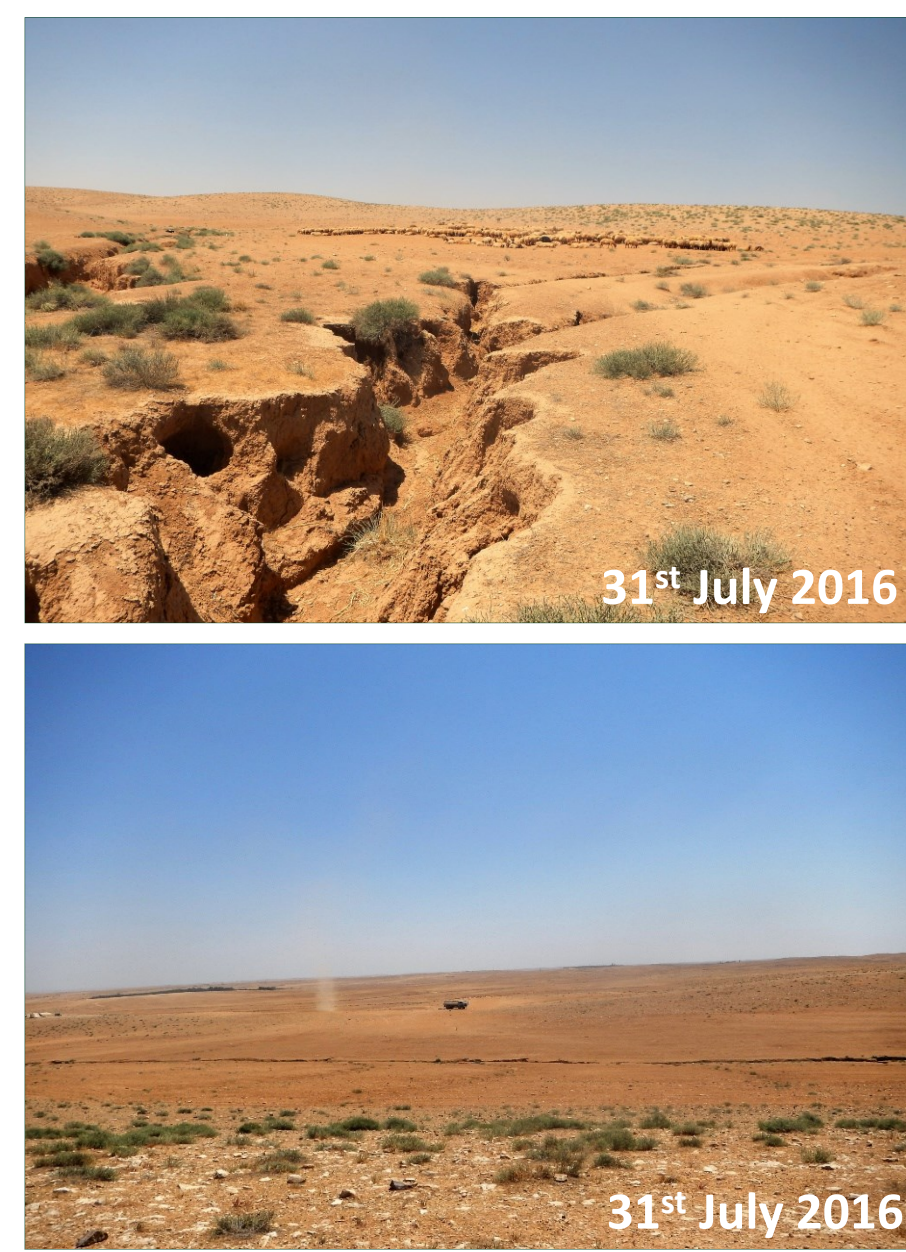
Figure 2. Initial condition of the research site

Al-Majeddyeh experimental site located approximately 10 km south-east of Amman. The site hosts several soil, water and vegetation related experiments. The climate is semi-arid; average annual rainfall ranges between 100 and 150 mm occurring during the rainy season from October to May. The local soil is a silt-loam and vegetation cover is sparse; only few percentage of the rangelands are covered with shrubs, while large areas, are plowed for barley agriculture. In 2016, ICARDA restored around 43 ha large area through an US Forest Service funded project. Around 15 ha of a 29 ha large upland watershed were treated by mechanized micro Water Harvesting.

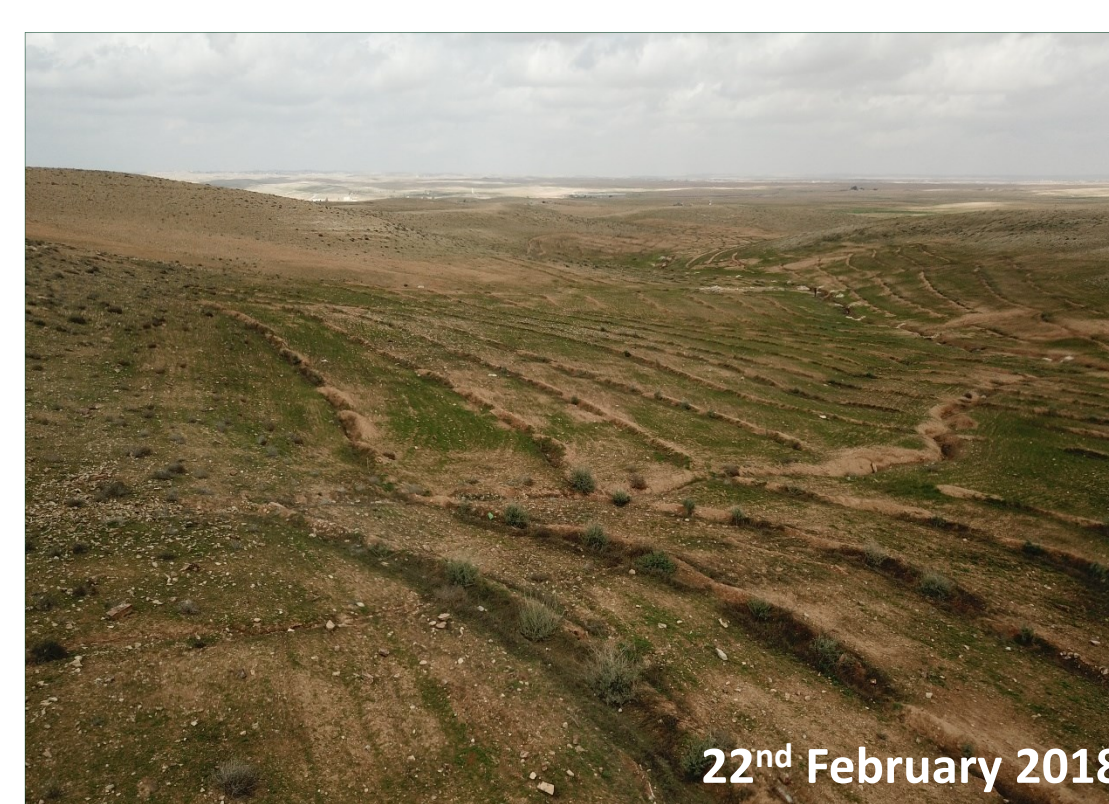
Figure 3. Treated watershed

Mechanized micro-WH was performed by 'Vallerani Delfino-Plow' system. The Vallerani system deep fractures the soil and creates intermitted semi-circular WH structures along the contour. degraded areas. In the Badia research site, in each of the WH pits two native shrub seedlings (Atriplex and Retama) were out-planted to develop vegetation islands, which spread-out over time and eventually restore degraded areas.

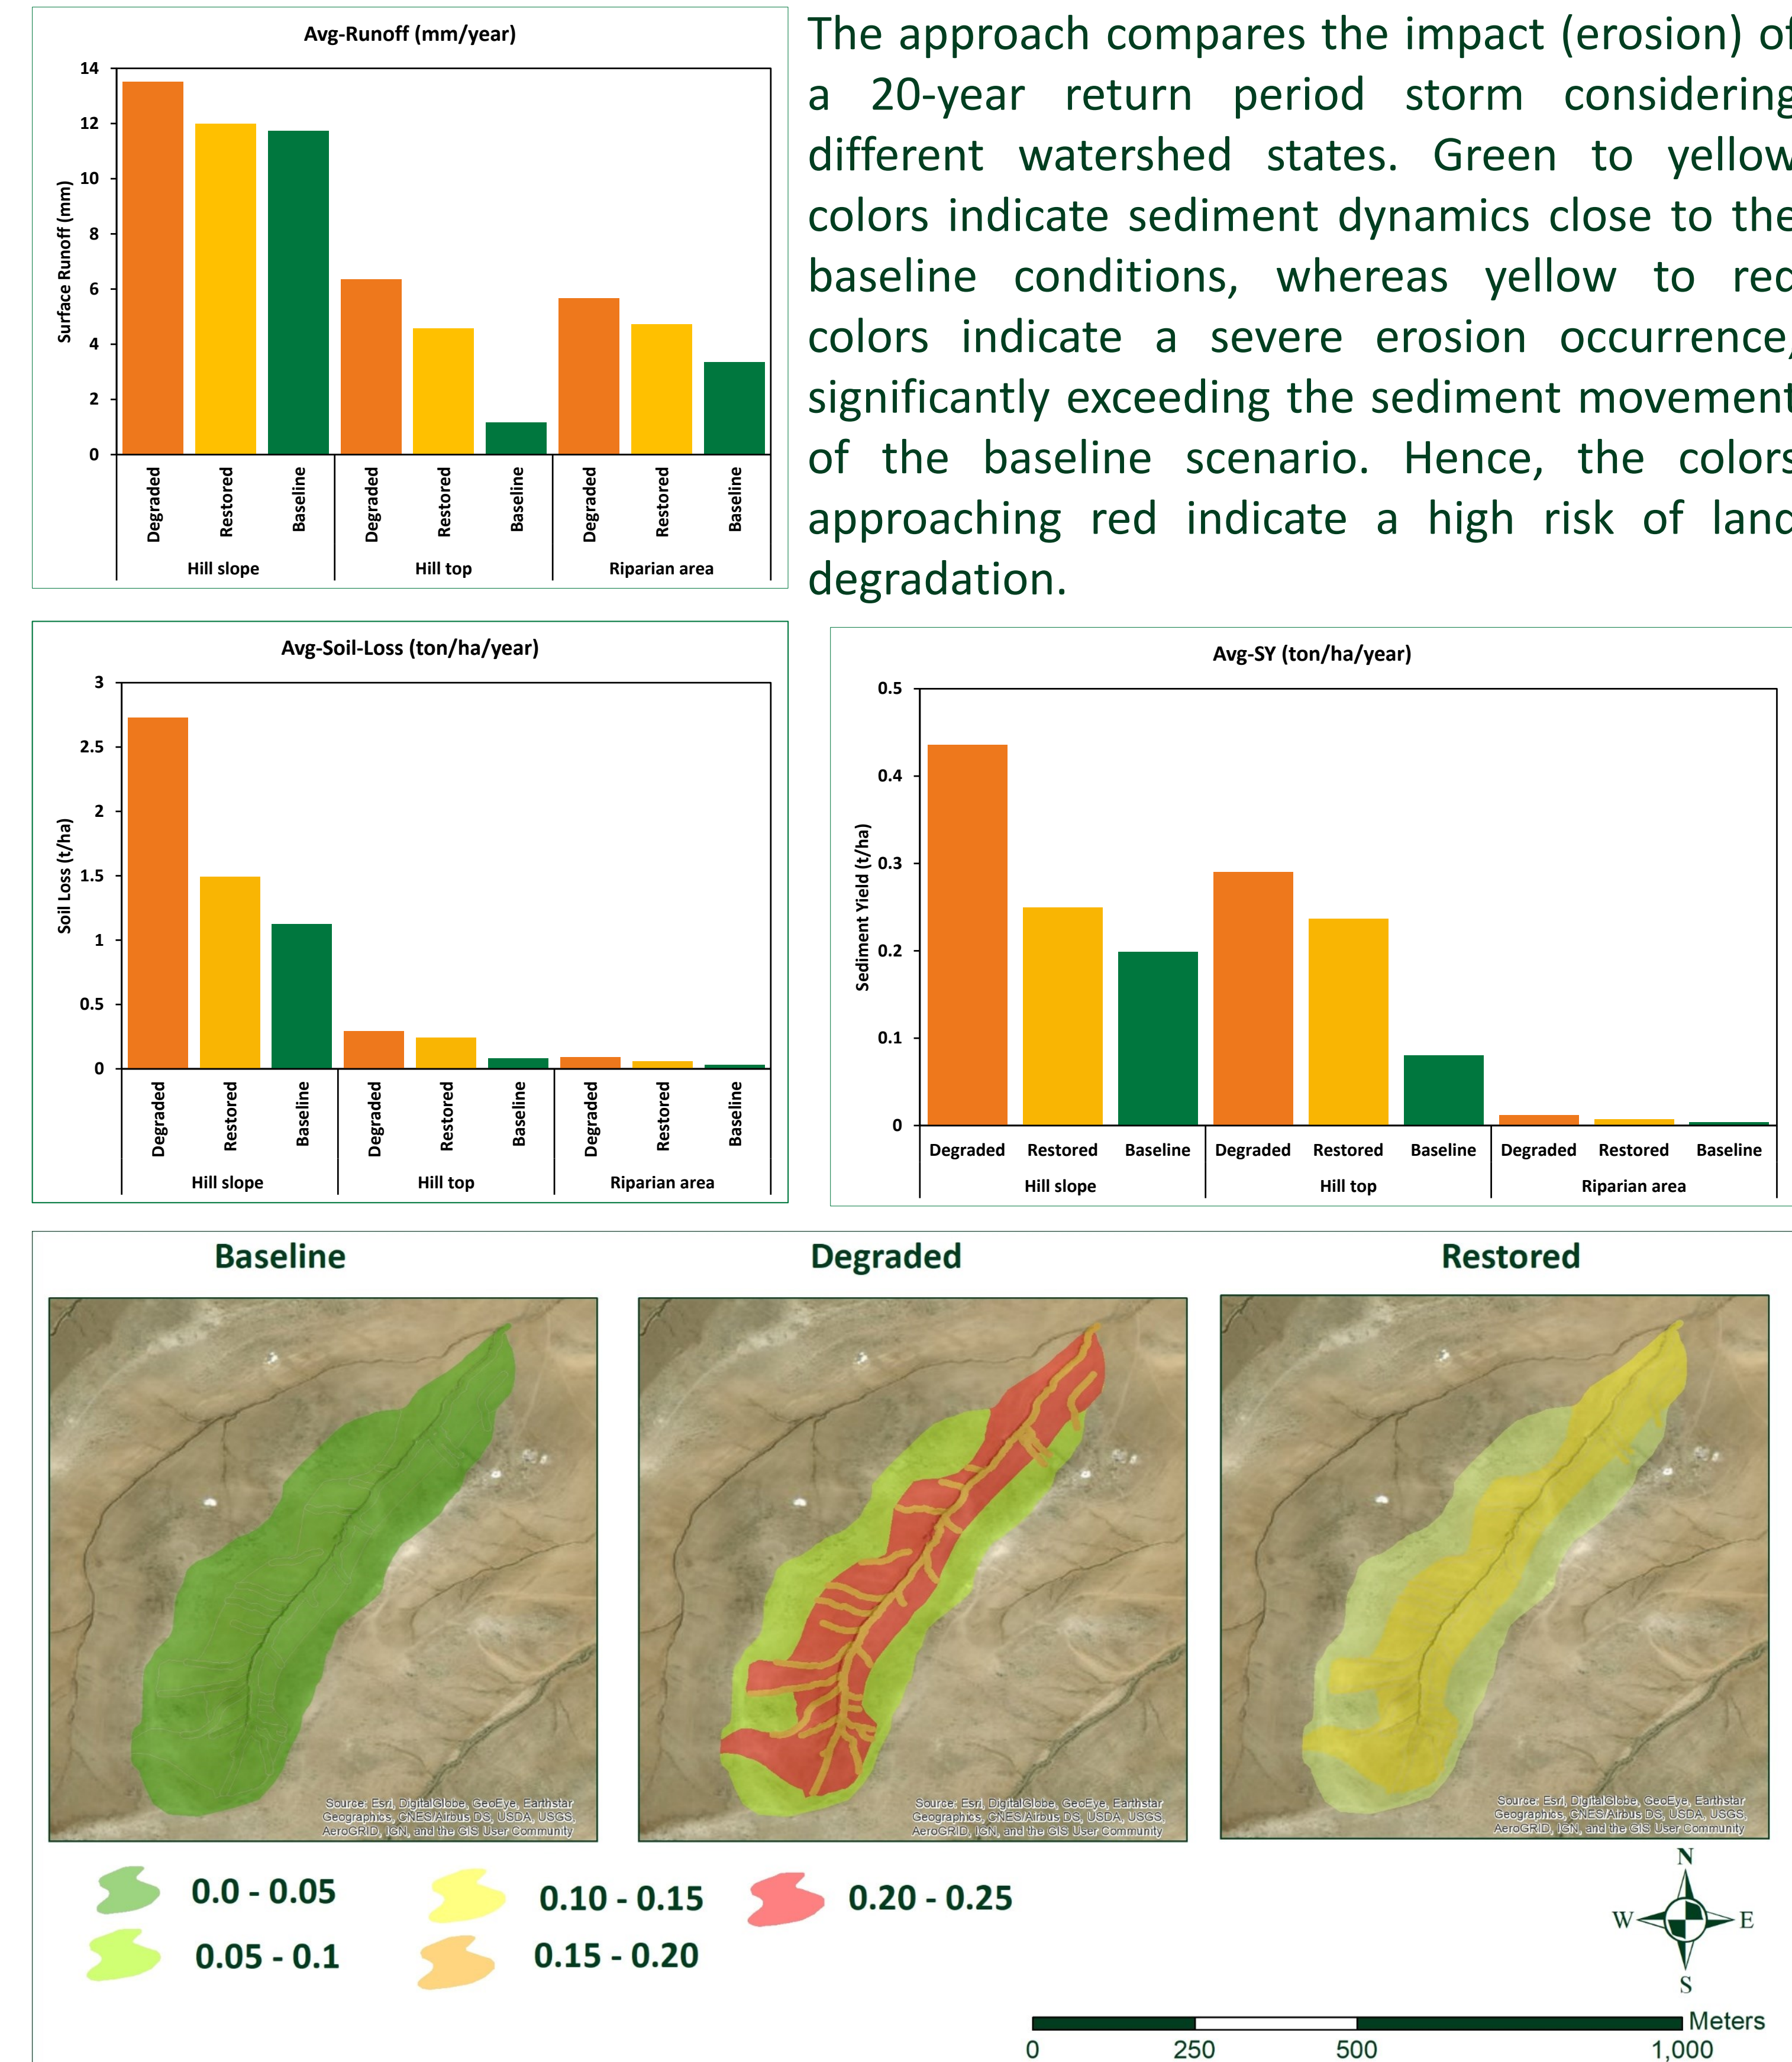
Figure 5. Risk assessment

The approach compares the impact (erosion) of a 20-year return period storm considering different watershed states. Green to yellow colors indicate sediment dynamics close to the baseline conditions, whereas yellow to red colors indicate a severe erosion occurrence, significantly exceeding the sediment movement of the baseline scenario. Hence, the colors approaching red indicate a high risk of land degradation.

Moreover, a risk approach was carried out evaluating the impacts of heavy rainstorms most significantly contributing to surface runoff and soil erosion. In this study a 20-year return period storm event was analyzed.
