University of Natural Resources and Life Sciences, Vienna

Master Thesis

ASSESSMENTS ON THE IMPACT OF STONE BUNDS ON WATER EROSION IN THE GUMARA MAKSEGNIT WATERSHED, NORTHERN ETHIOPIA

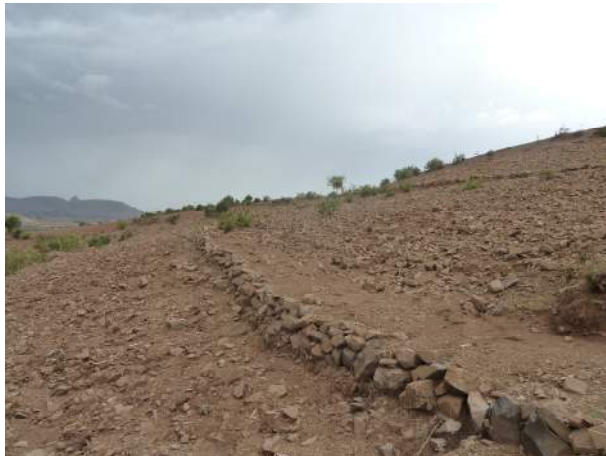
Figure 3: Representative stone bund in the Gumara – Maksegnit watershed

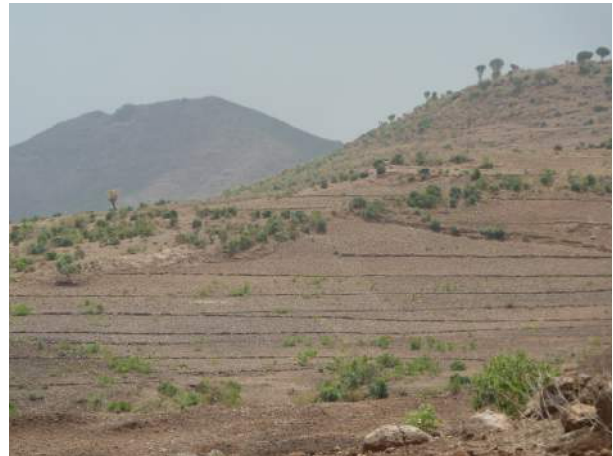
Figure 2: Sequence of stone bunds in the Gumara – Maksegnit watershed

The stone bunds in the Gumara – Maksegnit watershed are made out of rocks which are equally distributed over the cultivated lands. At first local farmers construct a stone bund – skeleton with stones of a size between 10 and 20 cm. Afterwards the holes and gaps become filled up with smaller stones. The height of a typical stone bund in that region ranges from 0.15 to 0.4 m. Nyssen et al. (2009) show that short - term effects of stone bunds are the reduction of the slope length and the creation of small retention basins for runoff and sediment. Short – term effects reduce the volume and erosivity of the overland flow and lead to a decrease of soil loss. The reduction of soil erosion rates due to the reduction of slope length by stone bund building can be compensated by an increase of soil erosion due to rock fragment removal (Nyssen et al., 2007).

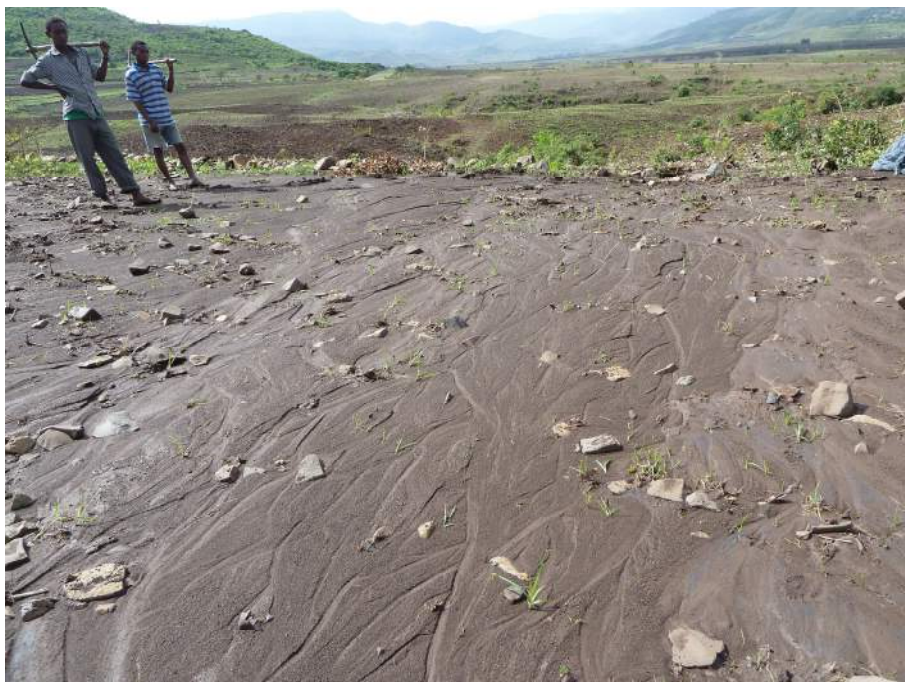
Figure 5: Accumulation of sediments in front of the stone bund

Desta et al. (2005) found out that stone bunds can reduce annual soil loss caused by sheet and rill erosion by 68%. The trapping efficiency decreases when the depression behind the stone bund gets filled, therefore regular maintenance and an increase of height are necessary in order to ensure the positive effect of a stone bund.

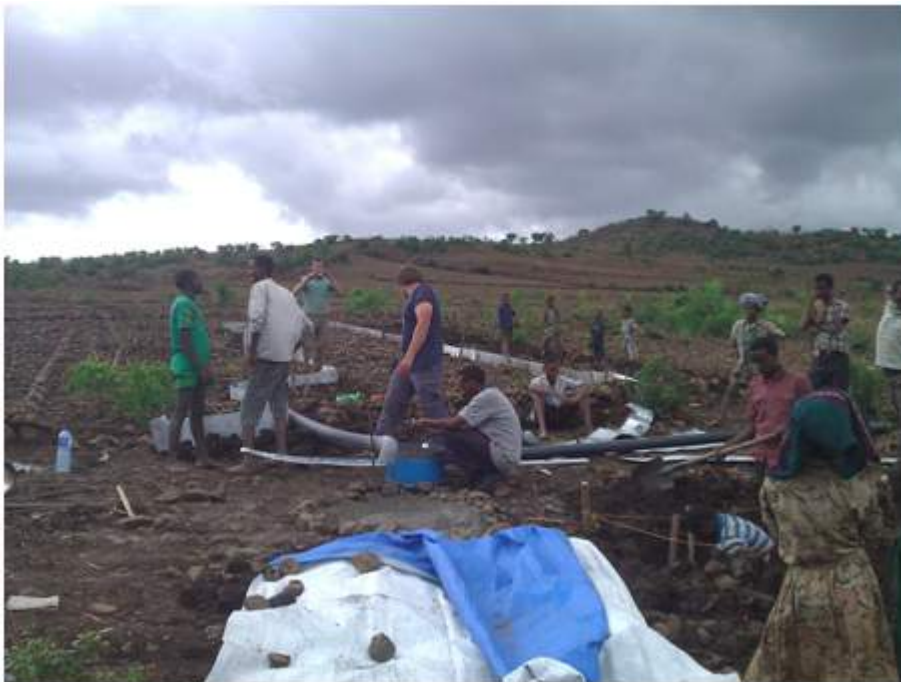
Figure 9: Construction works for the plots

The construction of the treated plot, which is shown at figure 9, started in the middle of June. It was very important to construct the plot fast, since the first big precipitation events of the annual rainy season occurred already in the beginning of June. Once the treated plot was constructed, the decision was made to construct the untreated plot in order to have reference data to compare with. On 4th of July the first samples from the treated plot could be taken and on 13th of July the first samples could be taken from both plots.

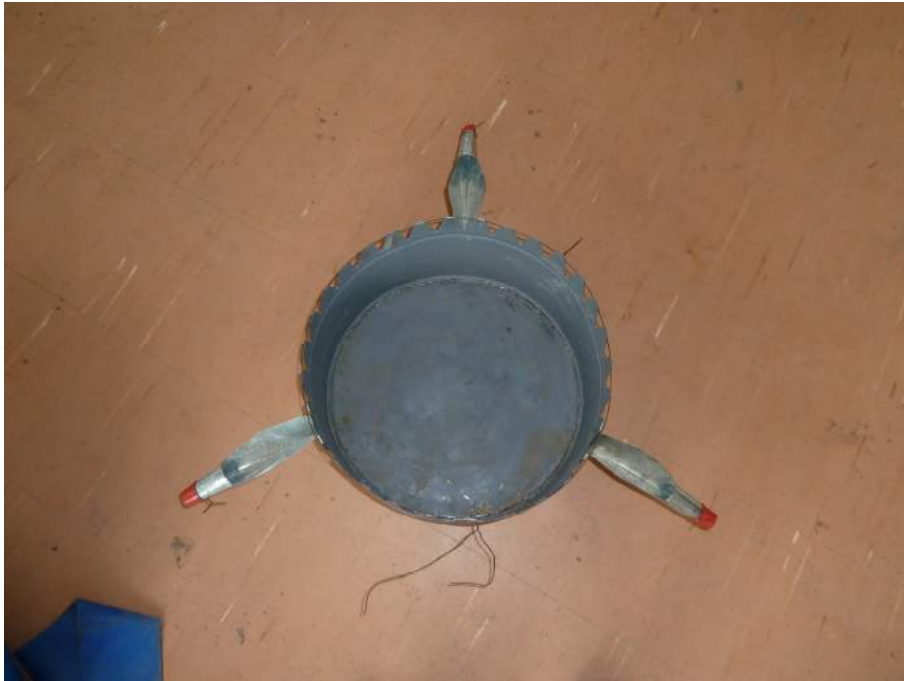
Figure 10: Sample-divider

Because of very high expected surface runoff, caused by high precipitation events, there was the idea of dividing the runoff into equal parts and transferring only a part of it to the sampling ponds. For that reason, the decision was made to use sample dividers. The possibility of building well working sample dividers was strongly limited. As material for building the dividers, there were only old iron barrels from a local market with a height of 90 cm and a diameter of 50 cm available. With an iron saw, one barrel was manually cut into two equal sized parts with a height of 45 cm. Then, at the open side of the barrel half, there were 30 (at the untreated plot) or 31 (at the treated plot) equal sized V - shaped apertures cut in similar distances along the circumference. As it is shown in figure 10, at every 10th opening there was a connection part installed, in order to connect a tube of 25 mm diameter with one aperture of the sample-divider. In total there are three connections for a tube per sample-divider in the same distance. With that system the transfer of 10.0% or respectively 9.7% of the total surface runoff from the plots to the ponds was possible.

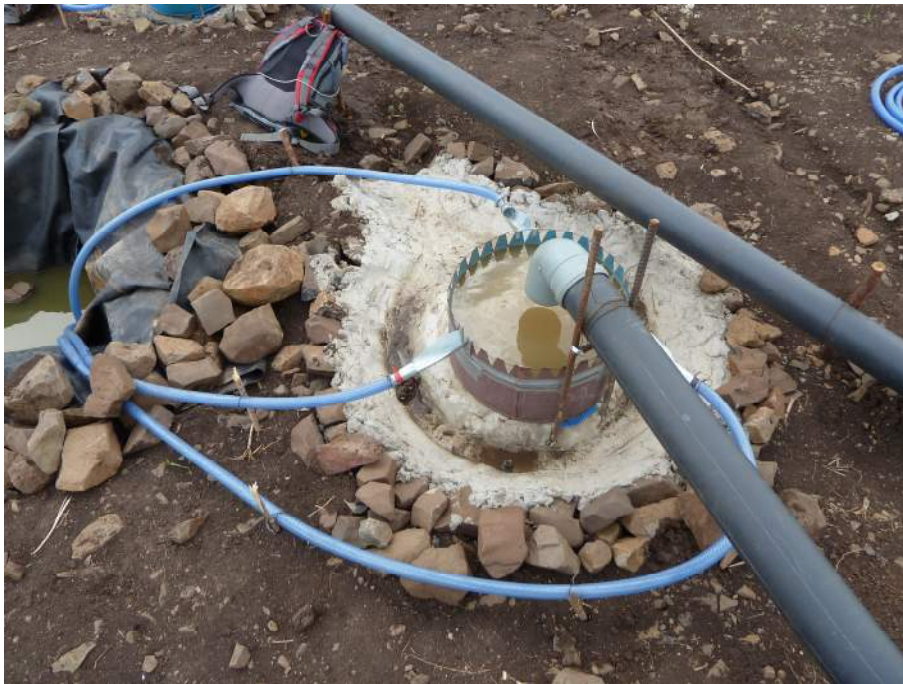
Figure 11: Sample-divider installed at the plot

Figure 11 shows the sample-divider installed at a plot. Three tubes of 25mm diameters transfer 10.0% or respectively 9.7% of the surface runoff from the erosion plots to the ponds. The sample divider is set up on a concrete foundation which is circuted by a concrete pan. The other 90% of the surface runoff, which are not transferred to the pond, flow through the apertures of the sample-divider into the pan and finally they flow via an outlet into a draining ditch. It took the first precipitation events to fill the divider with sediments. After that, all the sediments which came with new surface runoff went through the apertures of the divider equally.

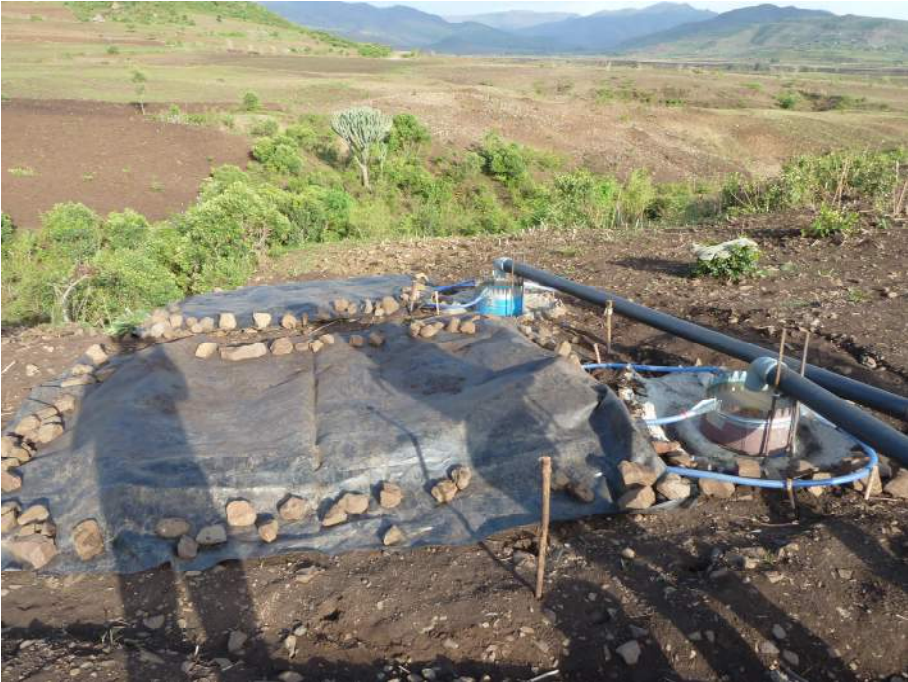
Figure 12: Covered ponds

The ponds were dug manually and their bottom was covered with a plastic foil to make it water proof. In order to prevent rainwater falling directly into the pond, it was covered by big corrugated iron pieces. In order to close every opening where water from the soil surface could enter, which is not coming from the sample-dividers, a final cover with a plastic foil over the corrugated iron pieces was used. For the purpose of stopping surface runoff from the outside of the plots to enter the ponds, a ditch was created around the ponds as a barrier for that water. Figure 12 shows the ponds of the treated plot when they were covered with corrugated iron sheets and with a plastic foil. In figure 13 you can see a full pond after heavy precipitation events, before taking samples and determining the total volume of stored runoff.

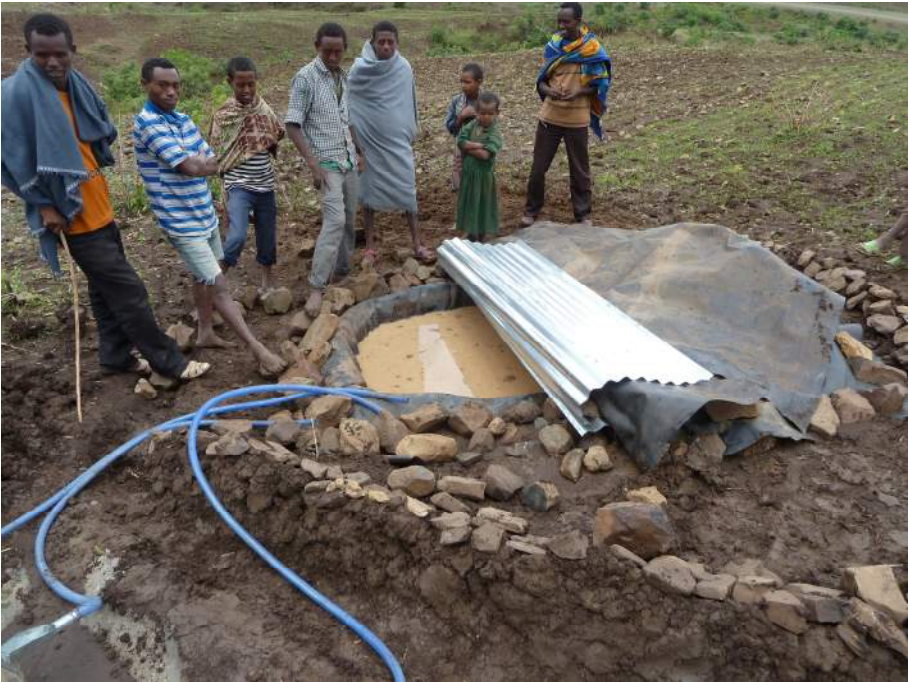
Figure 13: Full pond after heavy precipitation events

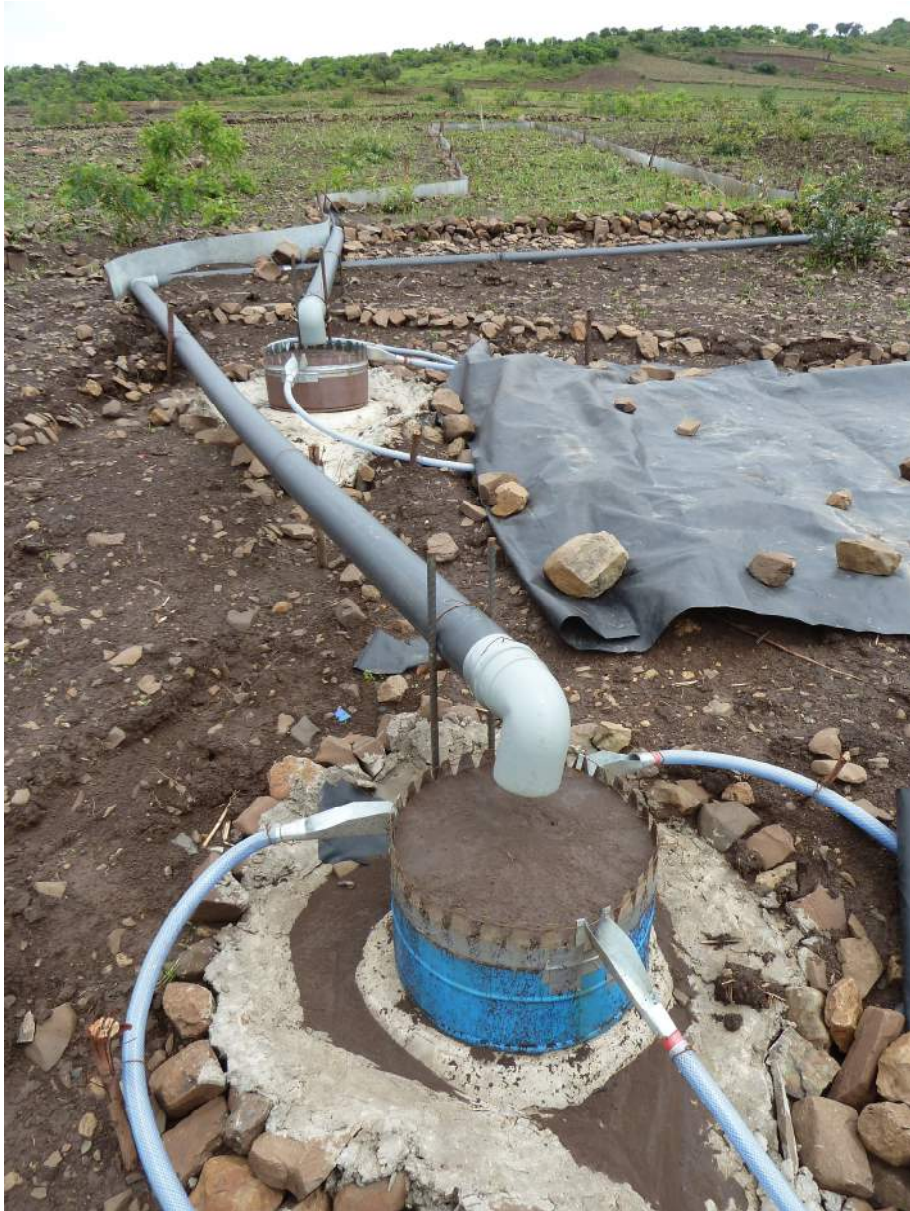
Figure 15: Treated plot, ready for operation

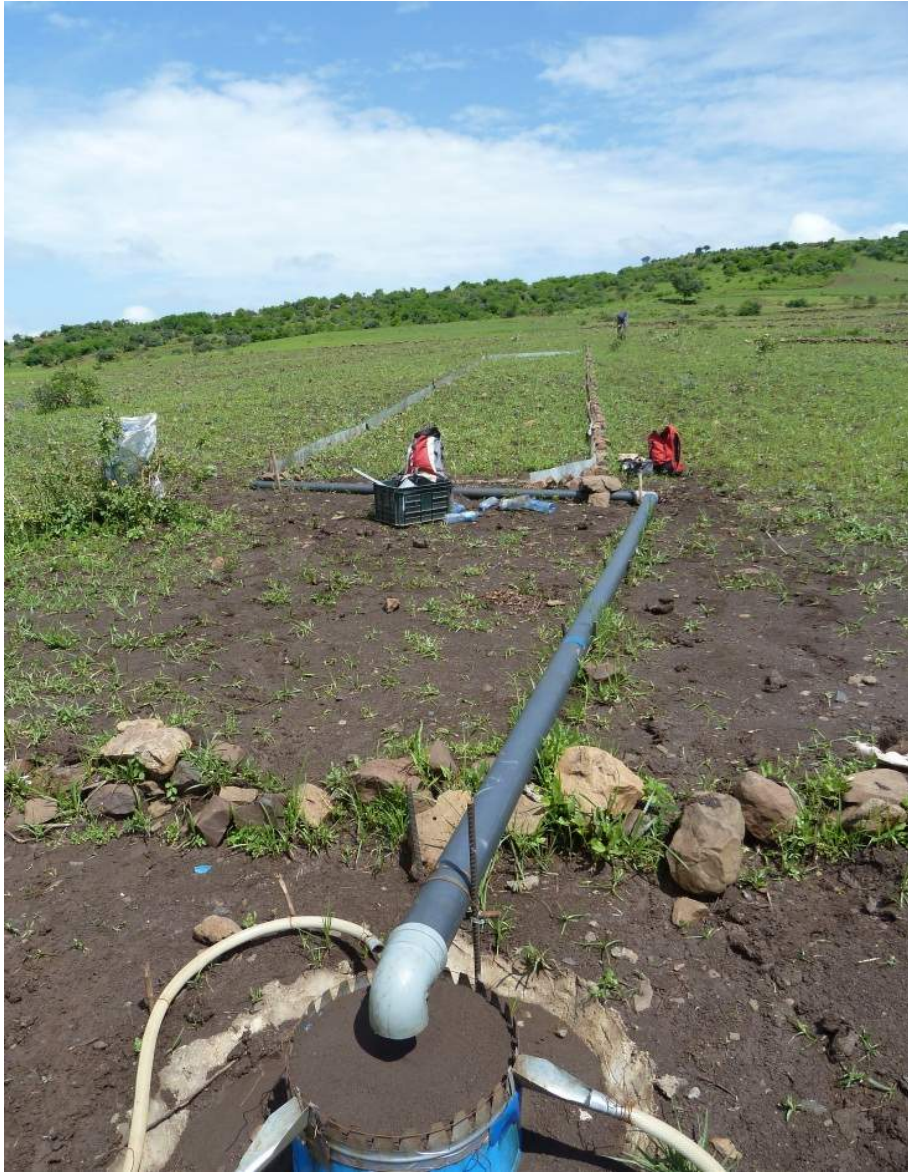
Figure 17: Untreated plot, ready for operation

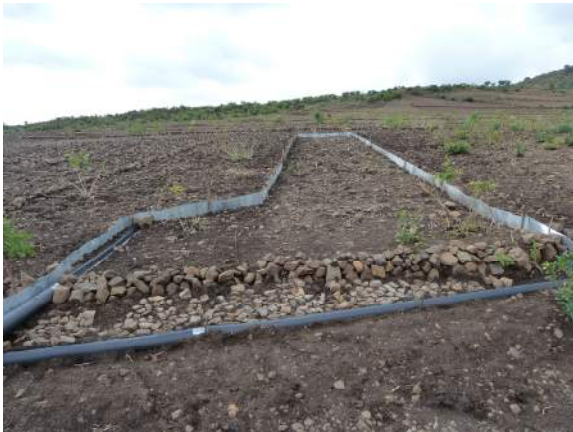
Figure 19: Stone bund before maintenance

In order to get data for the treated plot, which show the effect and the importance of the maintenance of a stone bund, the stone bund was maintained in the middle of the sampling period. On the 9th of August 2013 a team of three people spent two to three hours in order to maintain the stone with a length of 4.5 m. For that purpose, stones of 10 – 20 cm of diameter were collected in the field area and mainly used for the maintenance work. At first the width of the bund and it's ground area were increased. Finally, it's height was raised from 30 cm before maintenance to 50 cm after maintenance. After finishing the work, the bund was higher and also it's permeability of surface runoff and eroded soil particles was much less than before maintenance. Figure 18 and 19 show the stone bund in two different conditions: Before and after maintenance.

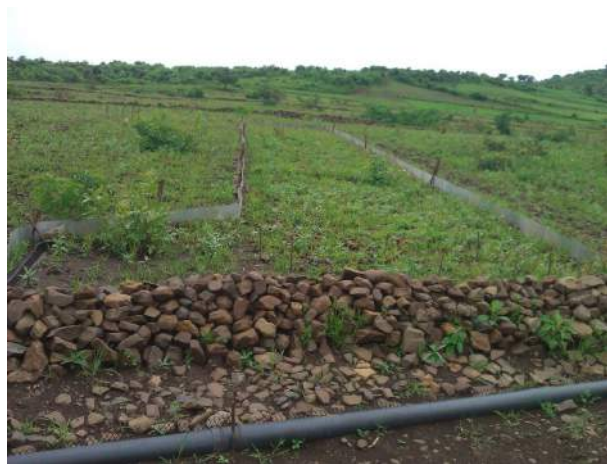
Figure 18: Stone bund after maintenance

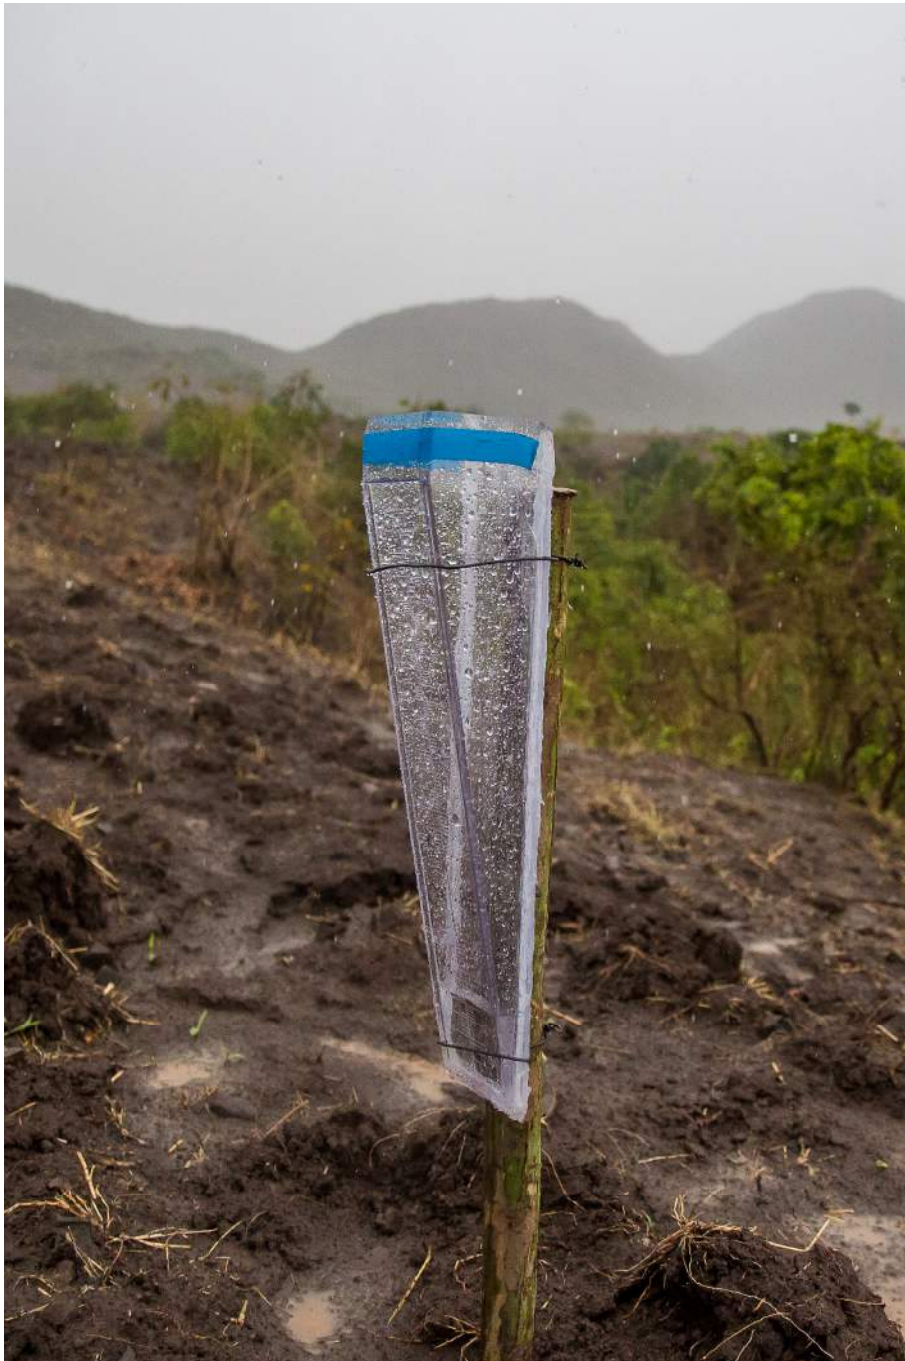
Figure 20: Manual rain gauge (photo: Christoph Schürz)

At the beginning of the construction of the erosion plots, several manual rain gauges have been installed in the whole watershed. The precipitation amount of the prior 24 hours was recorded daily at 7:00 am manually. After recording the precipitation amount, the rain gauge was emptied in order to be ready for the next measurement period. Figure 20 shows the gauging station, which delivered precipitation data for this thesis. It was located about 50 m far away from the plots.

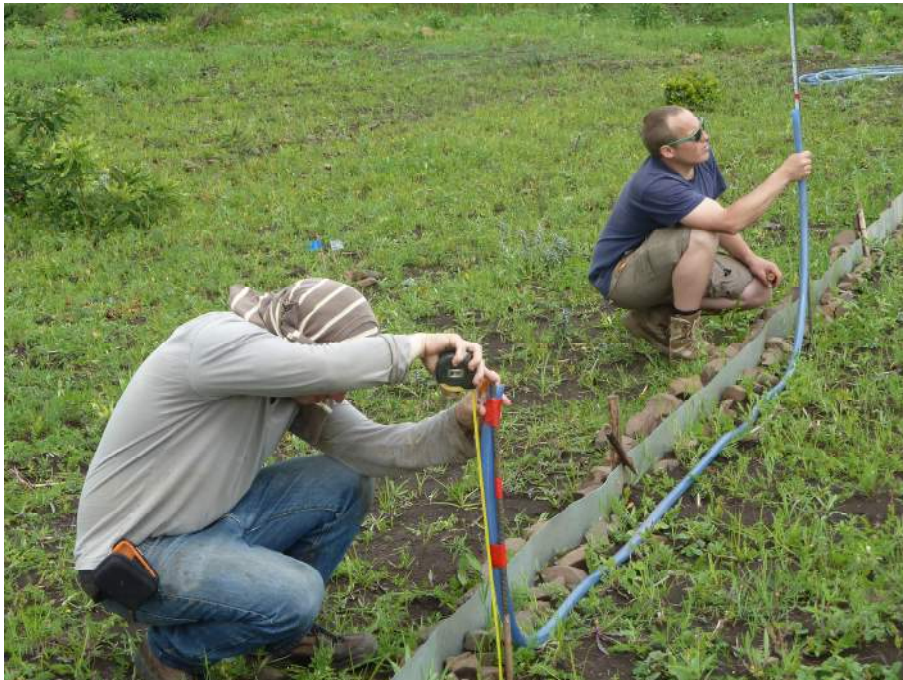
Figure 21: Surveying with a tube balance

In order to get information about the slope of both plots a survey of the study area was conducted. At first the coordinates of the upper and the lower point of one length side of each plot were determined with a hand – GPS. Then, every three to four meters the relative altitude of a point of the plot length had been measured. For that purpose a tube water level was used. It was made out of a plastic tube with a diameter of 3 cm and a length of 6 m. As it is shown in Figure 21, it was bonded to an iron stick of 1 m length at both endings. The tube was filled with water for about 80% while both endings were held highly over ground, so that the water could not get out of the tube. In order to start surveying, one corner point of the treated plot was used as a reference point with an assumed reference elevation of 0 m. Beginning from that point, every three to four meters along the boundary of the plots, the difference of the water level height at the tube water level was measured. All the water level differences were noted down in a sketch and the profiles of the plots could be drawn later in AutoCAD as it is visible in chapter 5.4.

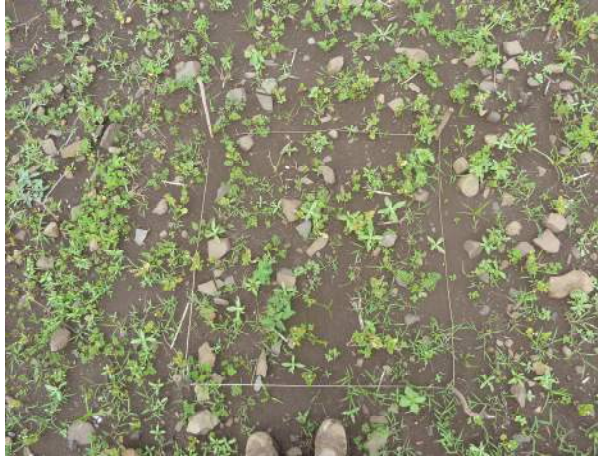
Figure 24: Photo of zone 1, ready for canopy cover determination

and leaf. In a next step the total area for each category can be calculated. The areas are given in pixels and their percentage is evaluated by dividing them through the total image area. The result of this evaluation is a trend of the development of canopy cover during the observation period.

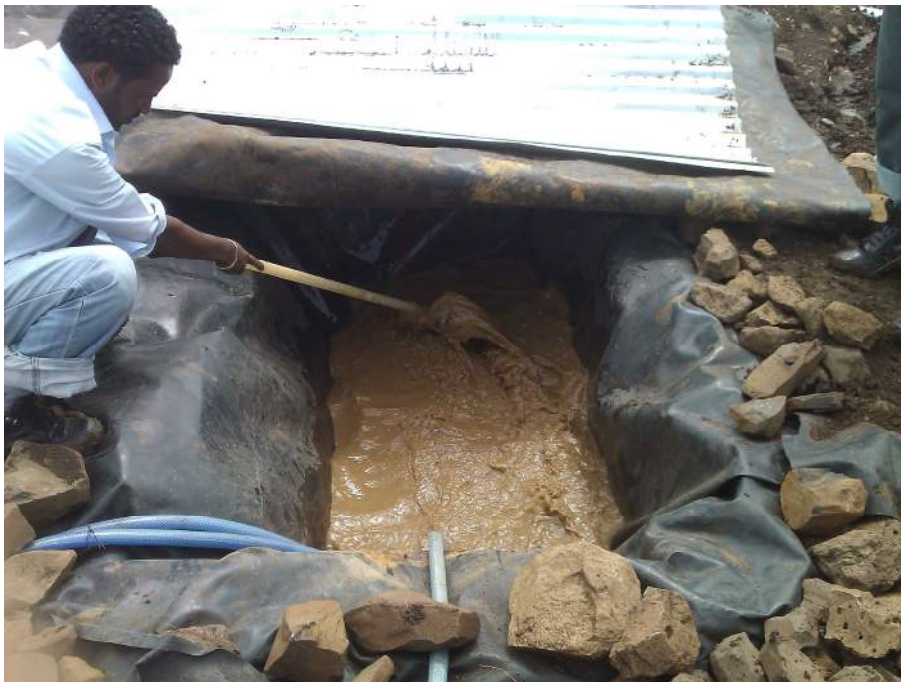
Figure 25: Stirring up the soil – water suspension in a pond before taking samples

This method was the most common one and it was used on twelve out of 13 times of taking samples. After discovering the ponds, the sediment on the bottom of the ponds had to be mixed with the water by stirring it up with a wooden or a plastic stick for approximately five to ten minutes, like it is shown in figure 25.

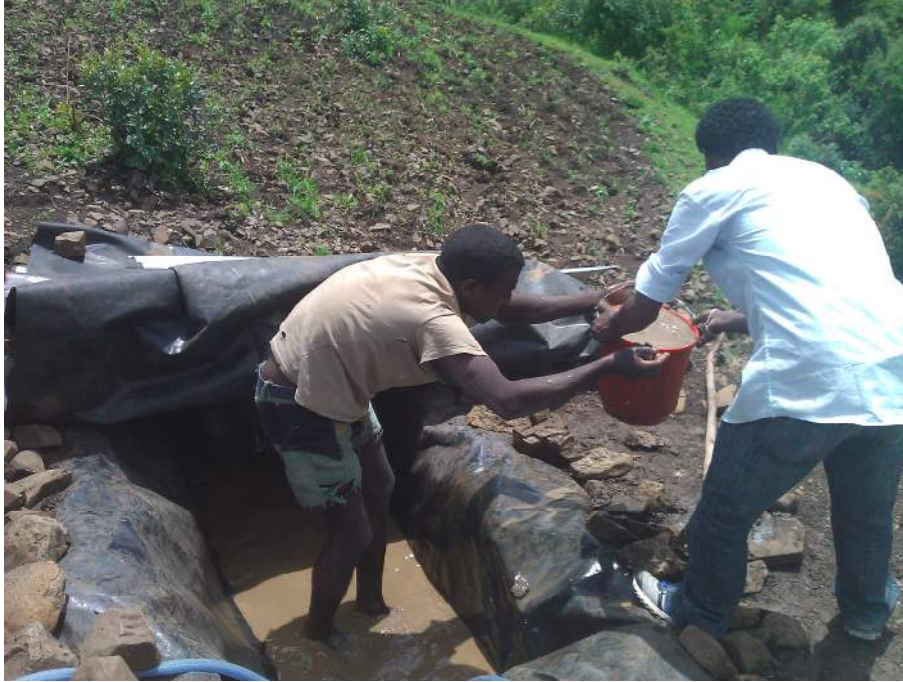
Figure 26: Estimating the water volume in a pond by emptying it with a bucket

After transforming into a homogenous suspension consisting of soil particles and rainwater, samples could be taken. Depending on the amount of totally stored water in the ponds, samples with volumes between 0.5 and 1.8 l were taken with empty plastic bottles and their sample volume was determined later exactly in the laboratory. After taking one up to three samples, the remaining volume of the ponds was emptied manually with plastic buckets of ten to 20 l like it is shown in figure 26. In that way the total volume of surface runoff in the ponds could be determined.

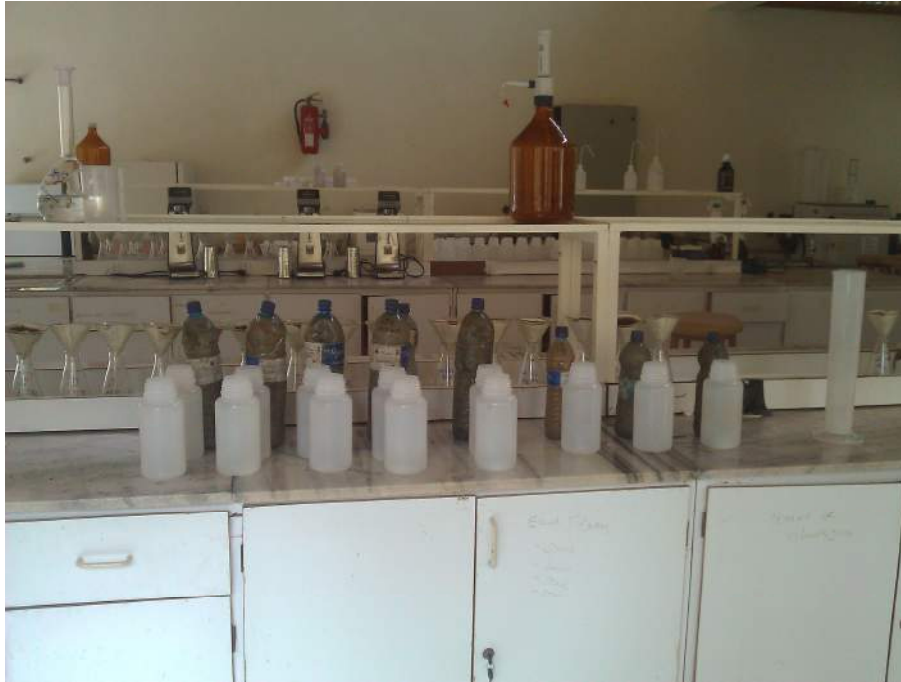
Figure 27: Soil samples in the laboratory before analysis

The evaluation of the sediment concentration in the samples was conducted in the laboratory. At first the volume of the runoff sample is evaluated with a 1000 ml measuring cup. Then the sample was transferred into a 1000 ml plastic bottle which is suitable for laboratory issues, like it is shown in figure 27. In order to ensure the sedimentation even of the smallest particles (silt, clay) the addition of a flocculation agent is necessary. For that reason 10 ml of a KCl – solution was added per a liter of runoff sample. The concentration of the KCl solution was 74.6 gram of KCl per 1000 ml.

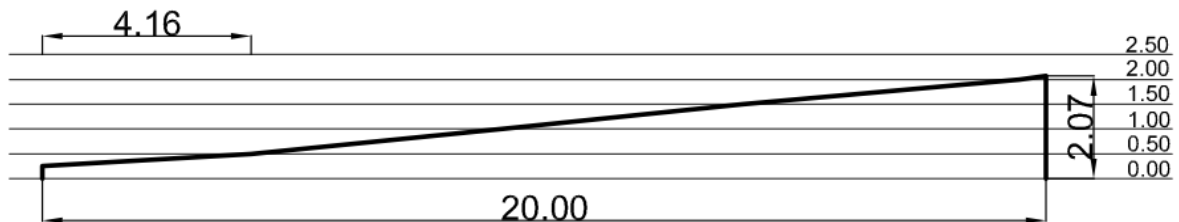
Figure 34: Length - profile of the treated plot

In the length – profile of the treated plot it is possible to see the accumulation zone up to 4.16 m before the stone bund where the inclination of 6% is lower than the average slope of 9%. The inclination uphill the accumulation zone is almost equal over the whole slope length and it is at 10%.

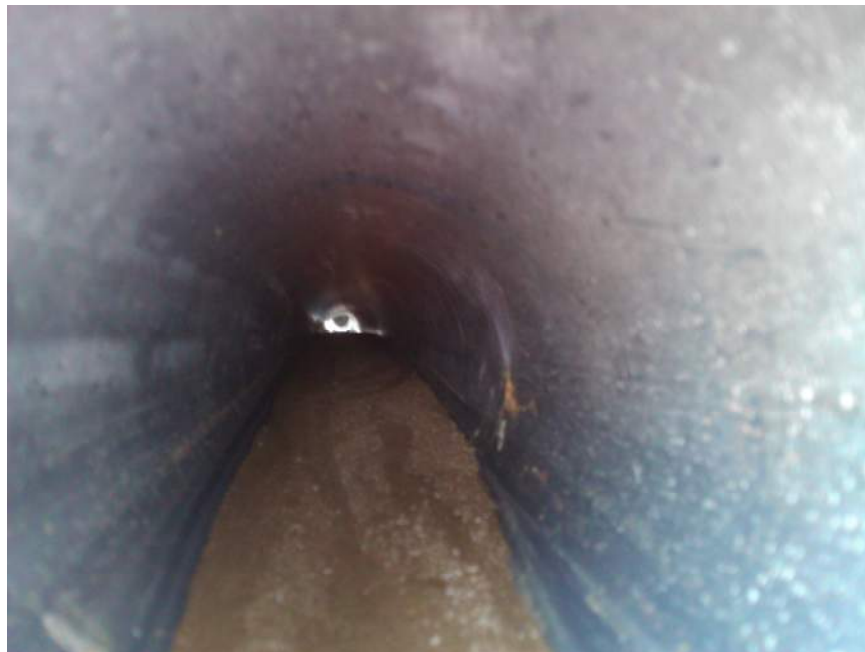
Figure 37: Clogged tube of the untreated plot

The conduit pipe of the untreated plot, which transfers the surface runoff to the sample divider was clogged totally by sediments until up to approximately 50% of its height as it is shown in figure 38. The tube was cleaned and freed from sediments totally. It is assumed that until that day, the runoff data and the soil erosion data from the untreated plot are not reliable, because the clogging of the conduit pipes was not realized for the first 20 days of measurement and therefore it could be the main reason for huge differences between data from the treated and the untreated plot.

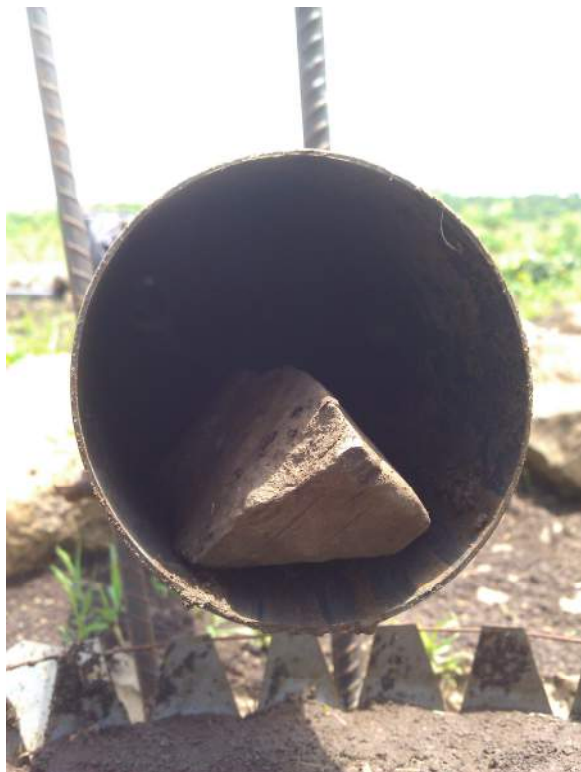
Figure 38: A big stone blocking a tube of the untreated plot

Because of the small amounts of collected surface runoff in all three ponds, the total amount of collected runoff has been sampled and its sediment concentration had been determined. In the conduit pipe of the untreated plot one big stone could be found and removed. It was obvious that the stone was put inside the tubes by humans, maybe by some local kids which wanted to play a prank. This may caused an error of the data.

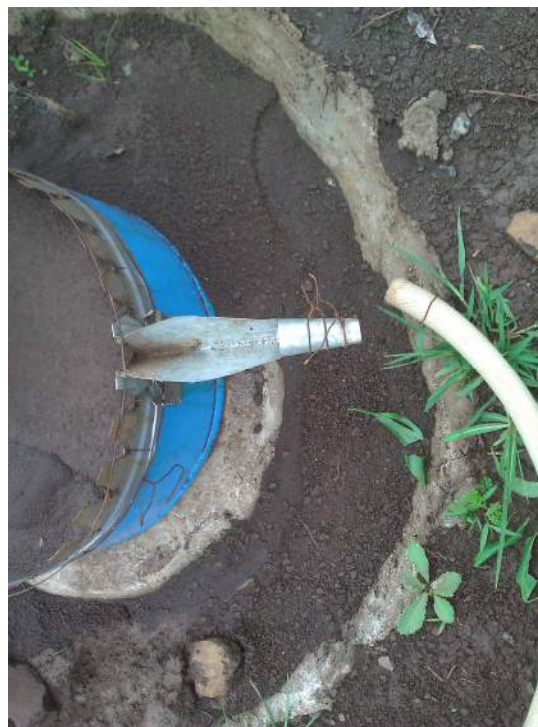
Figure 39: Removed connection tube between the sample divider and the pond of the UT plot

One of the three connection tubes between the sample divider and the pond of the untreated plot was removed because of an unknown reason, as it is shown in figure 40. Also the collection tube of the untreated plot was clogged by sediments, which could be removed and analyzed separately. After referring its' sediment concentration to the collected runoff amount in the UT pond, the sediment concentration was added to the before determined average sediment concentration, resulting in the S.c. average new value, as it is shown in Table A2.8b.
