Master Thesis

Evaluation of the Impact of Stone Bunds on Soil Loss and Surface Runoff in the Gumara-Maksegnit Watershed, Northern Highlands of Ethiopia

Vienna, May 2016

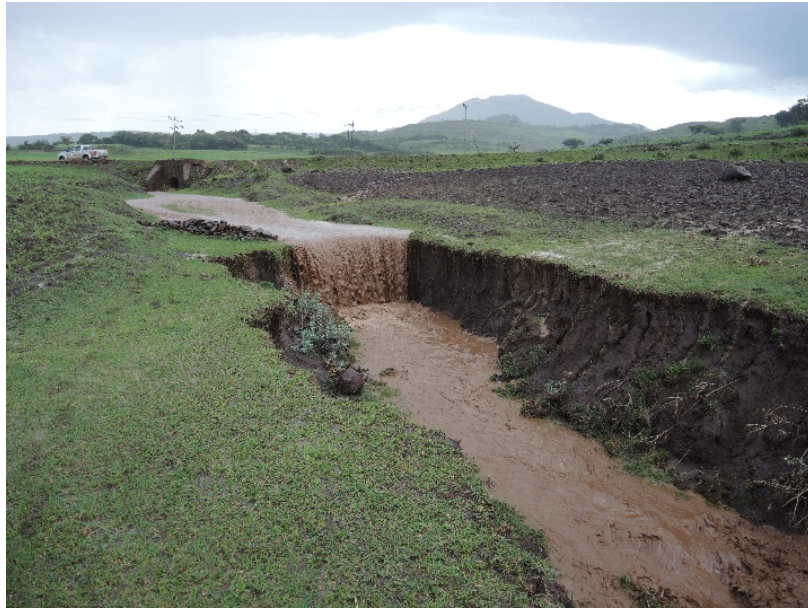
Figure 3-4: Gully Erosion in the Gumara-Maksegnit watershed (photo: S. Wakolbinger)

Where the inclination is at least locally steep and heavy rainfall occurs, erosion can lead to great incisions and form gullies. They are either U- or V-shaped channels and are wider and higher than 0.3 m. This form of erosion is irreversible by normal farm practices, the development of these gullies can fragment farmland and make cultivation impracticable (Blanco and Lal, 2008, p.24; Van Camp et al., 2004).

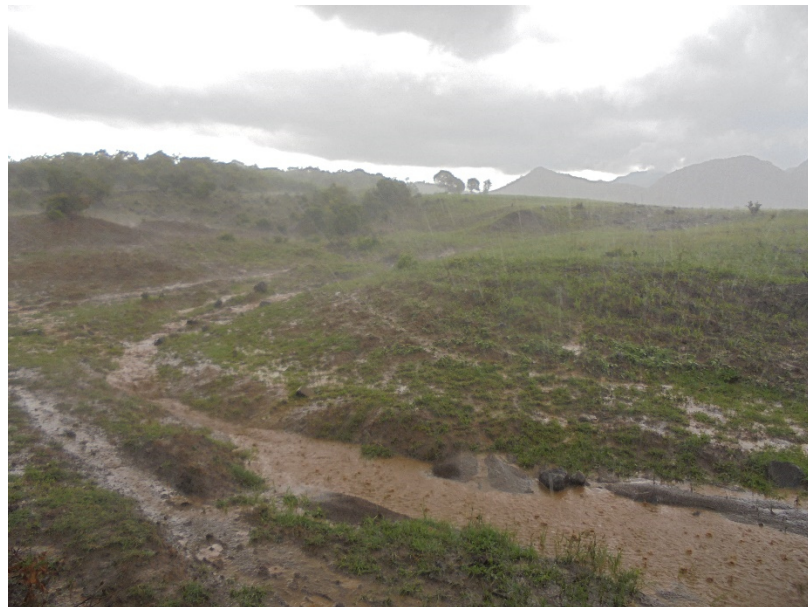
Figure 3-5: Photo series Part I: Rill erosion at the beginning of a heavy rainfall event in the Gumara-Maksegnit watershed (photo: S. Wakolbinger)

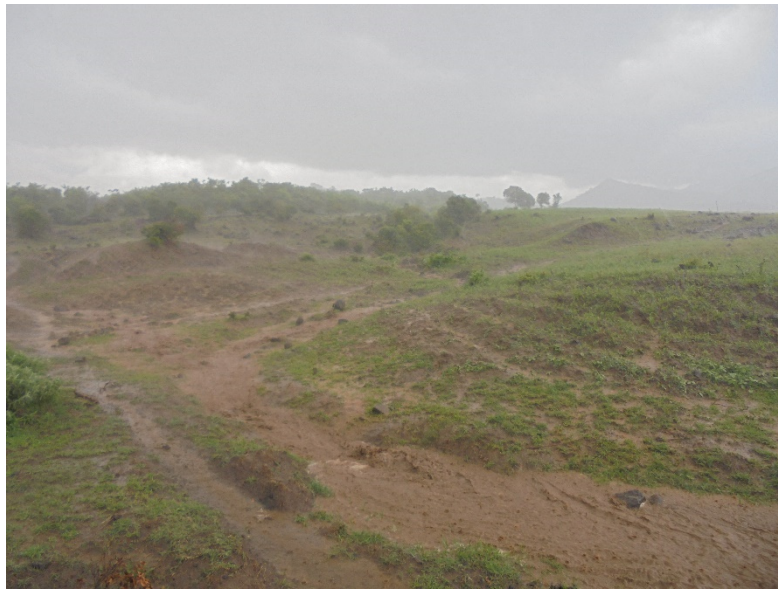
Figure 3-6: Photo series Part II: Rill erosion during a heavy rainfall event in the Gumara-Maksegnit watershed (photo: S. Wakolbinger)

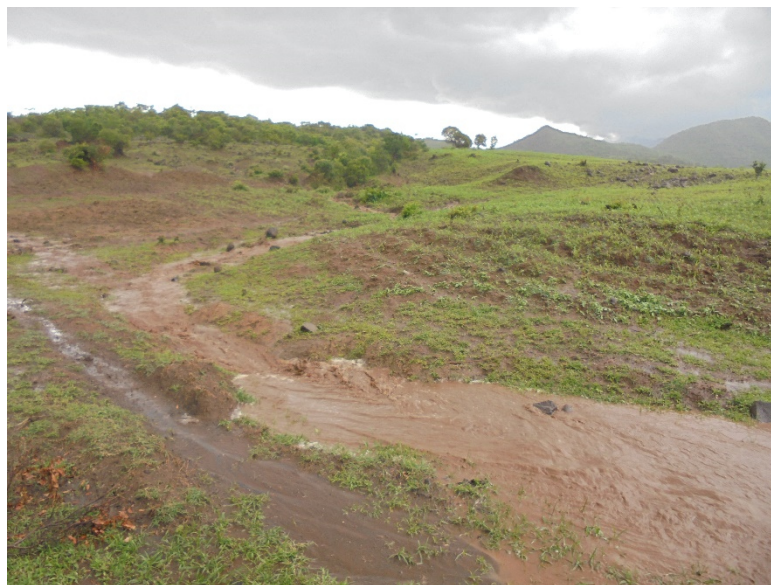
Figure 3-7: Photo series Part III: Rill erosion and deposition of sediment after a heavy rainfall event in the Gumara-Maksegnit watershed (photo: S. Wakolbinger)

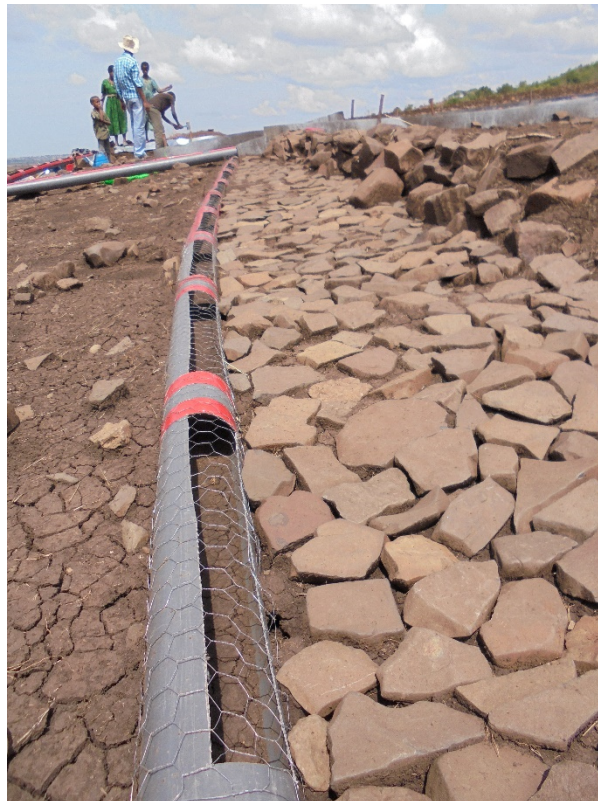
Figure 4-5: Collection pipe with mesh wire cover (photo: S. Wakolbinger)

At each plot, two pipes with openings were installed to collect the surface runoff. One pipe was situated at the right hand side to collect the sideflow (SF), which ran along the stone bund and the other pipe was dug into the ground below the stone bund to collect the overflow (OF). The openings of the pipes were covered with mesh wire to prevent stones from entering.

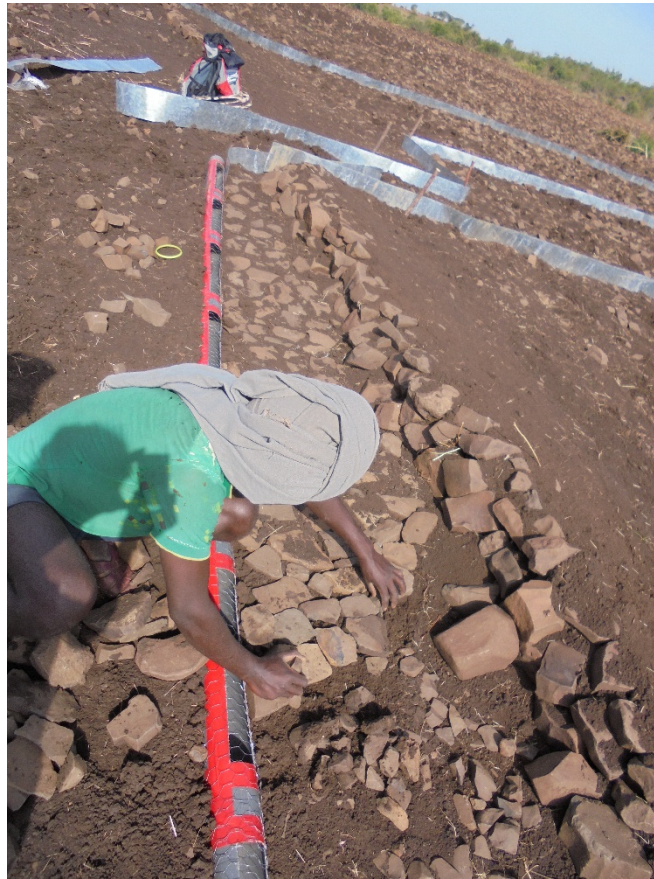
Figure 4-6: Installation of stone terraces (photo: S. Wakolbinger)

Between the stone bund and the collection pipe, a stone terrace was built. This was done to prevent the runoff from infiltrating after the stone bund and to lead the runoff straight into the collection pipes. The stone terraces were plastered with stones the size of 5 to 10 cm.

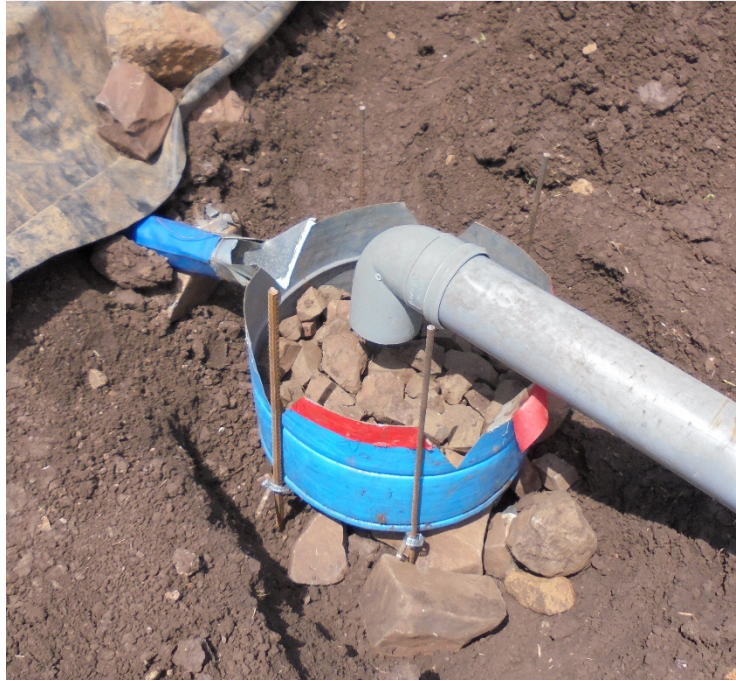
Figure 4-7: Sample divider (photo: S. Wakolbinger)

The runoff was transported by the collection pipes towards the multi-slot sample dividers. The sample dividers were constructed of iron barrels with a height of approximately 30 to 45 cm. Five identical V-shaped cuts were made along the open side of the barrel, these openings had the same distance to another. The sample dividers were situated on an iron bar construction, which put the sample dividers in a horizontal position. As one can see in Figure 4-7 only one opening was linked to a connection pipe, therefore it was possible to collect just 20 % of the runoff. This was necessary because of the high runoff values and the limited space and material for the collection ponds.

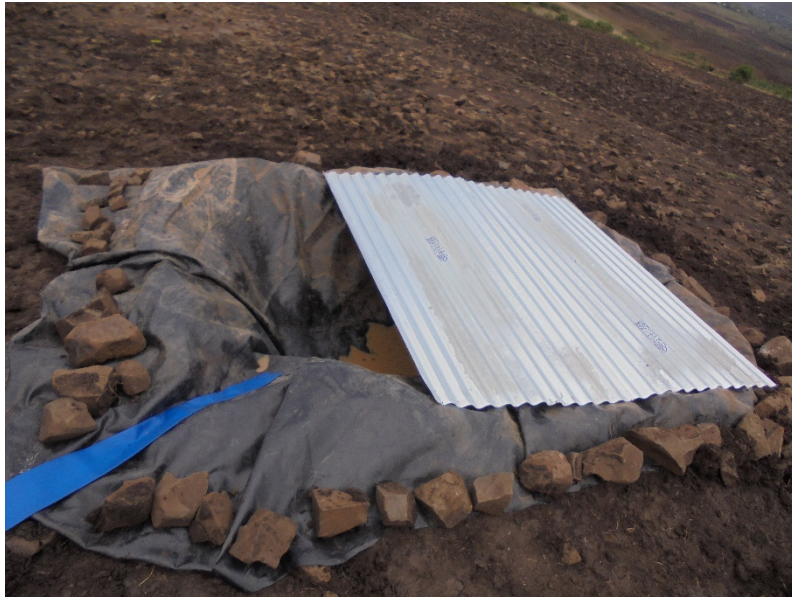
Figure 4-8: Open collection pond (photo: E. Obereder)

Following the division, the runoff was stored in collection ponds. The ponds were about 2 m long, 1.2 m wide and 1 m deep. They were lined with plastic foil to stop the water from infiltrating into the ground. At the edges of the ponds the plastic foil was fixed with stones and covered with soil to prevent the excess runoff from outside the plots from entering underneath the foil. The ponds were furthermore covered with corrugated iron sheets plus extra plastic foil and stones to create a closed system and to protect the iron sheets from strong winds. This closed system prevented the collected runoff from evaporating and stopped the rainfall from falsifying the results. In Figure 4-8 and Figure 4-9 one can see an open and a closed collection pond.

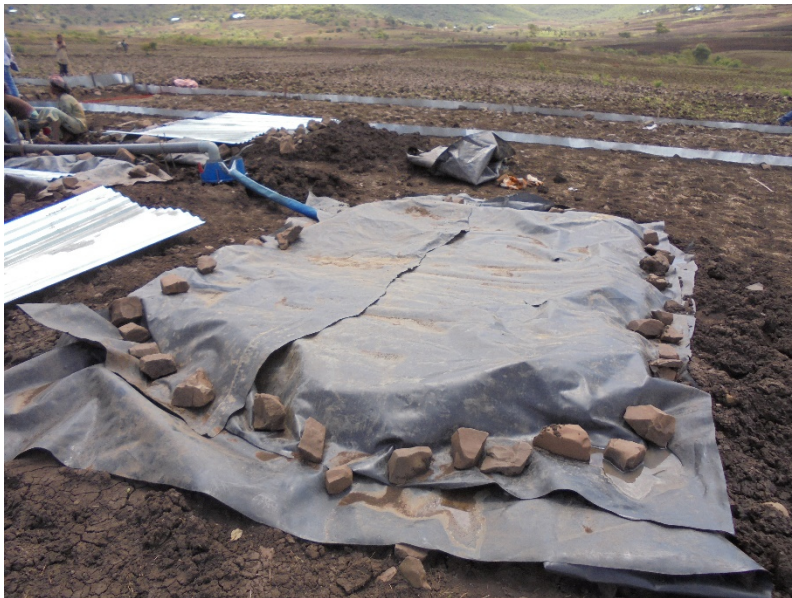
Figure 4-9: Collection pond covered with corrugated iron sheet, plastic foil and stones (photo: E. Obereder)

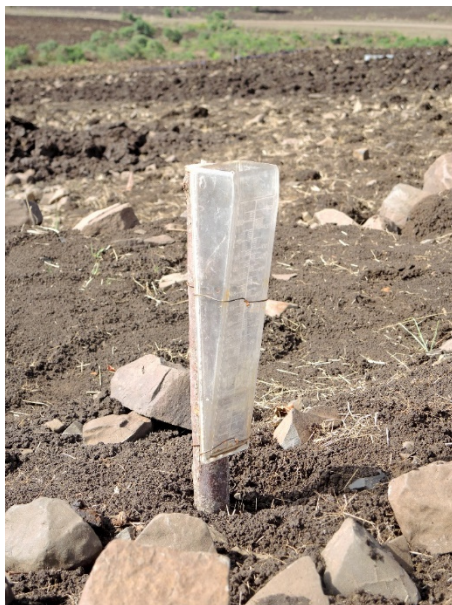
Figure 4-11: Manual rain gauge (photo: E. Obereder)

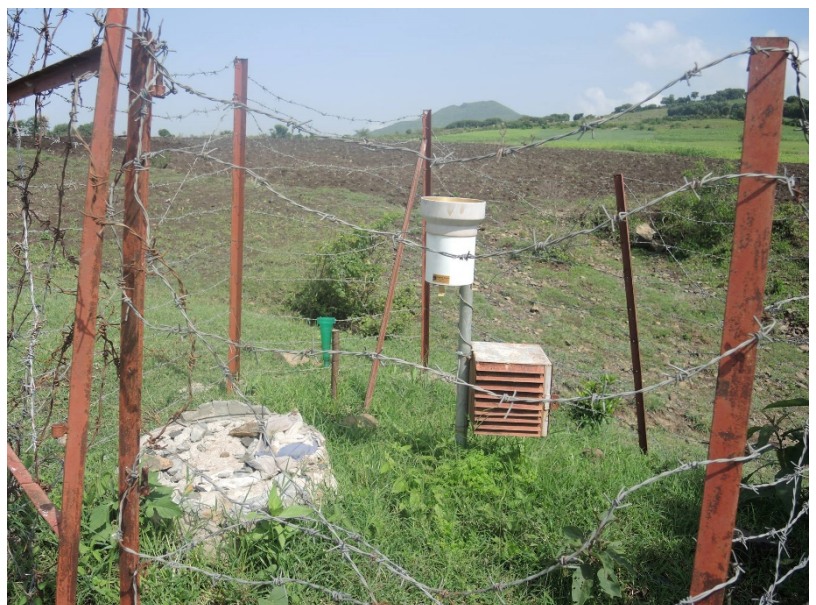
Figure 4-12: Tipping bucket ombrometer (photo: N. Demelash)

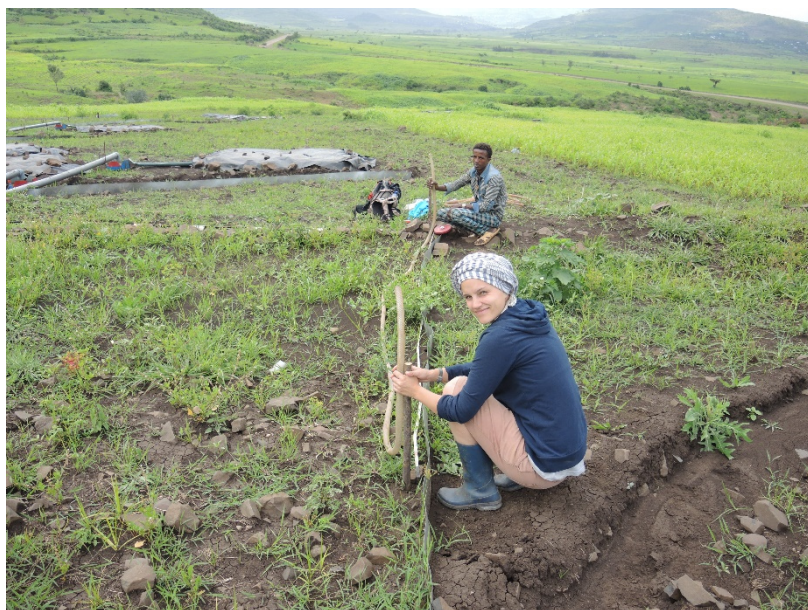
Figure 4-13: Inclination assessment with the tube water level (photo: E. Obereder)

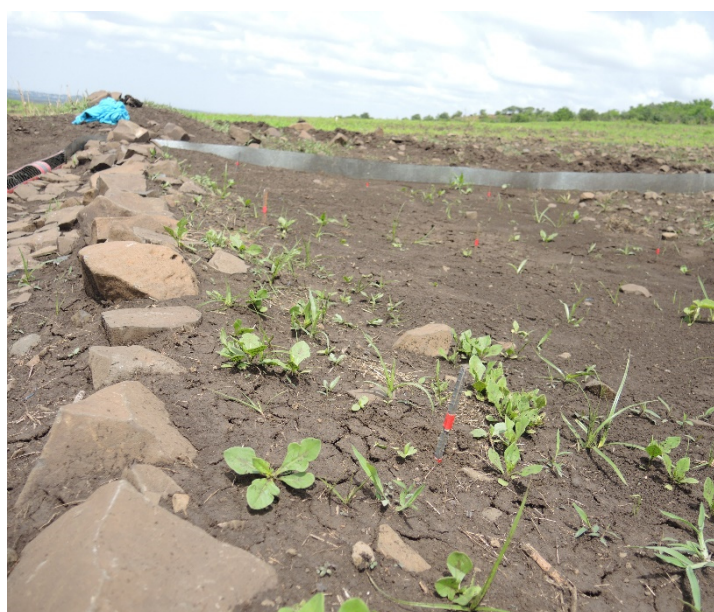
*Figure 4-15: Erosion pin arrangement in the accumulation zone
(photo: S. Wakolbinger)*

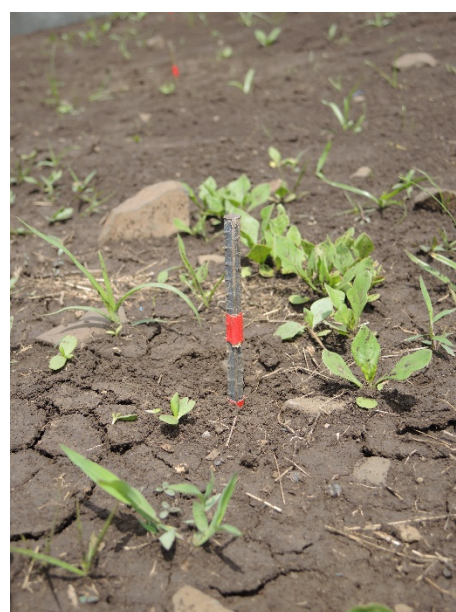
*Figure 4-16: Single erosion pin
(photo: S. Wakolbinger)*

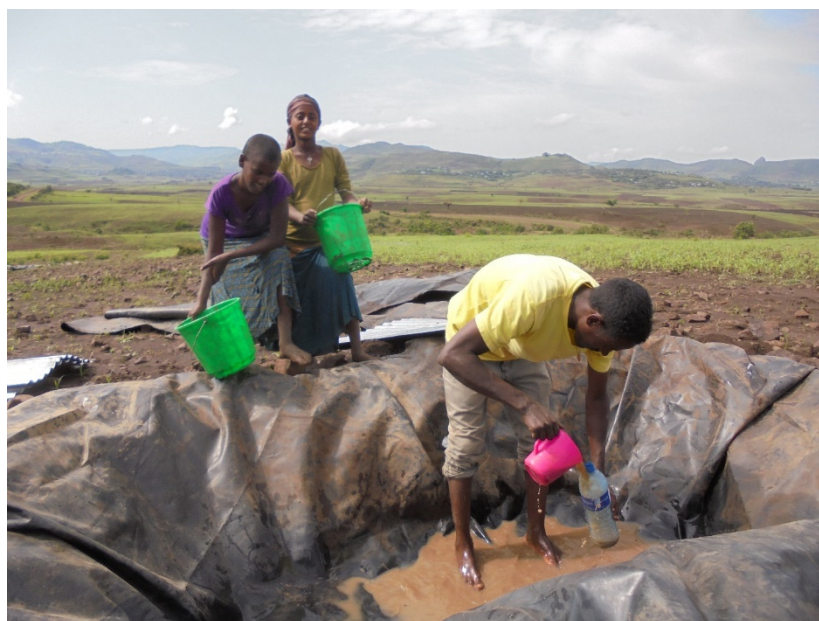
Figure 4-23: Demonstration of the sampling process (photo: S. Wakolbinger)

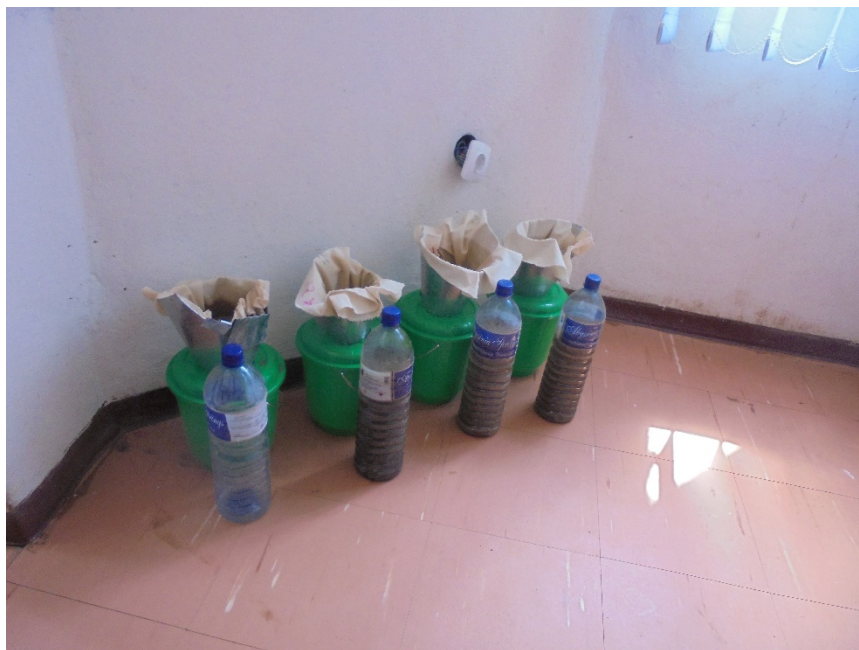
Figure 4-24: Filtering system including plastic buckets, metal cones and textile filters (photo: S. Wakolbinger)

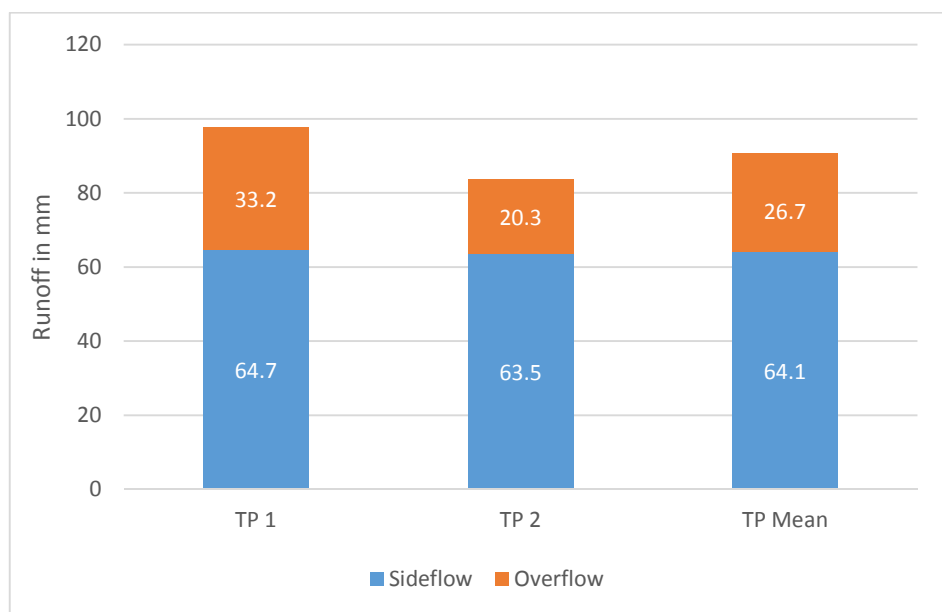
Figure 5-1: Total runoff values (side- and overflow) of the TP 1 and TP 2, including the mean value of the treated plots

Figure 5-1 and Figure 5-2 show the total runoff values for all four plots, including the mean values of the treated and untreated plots.

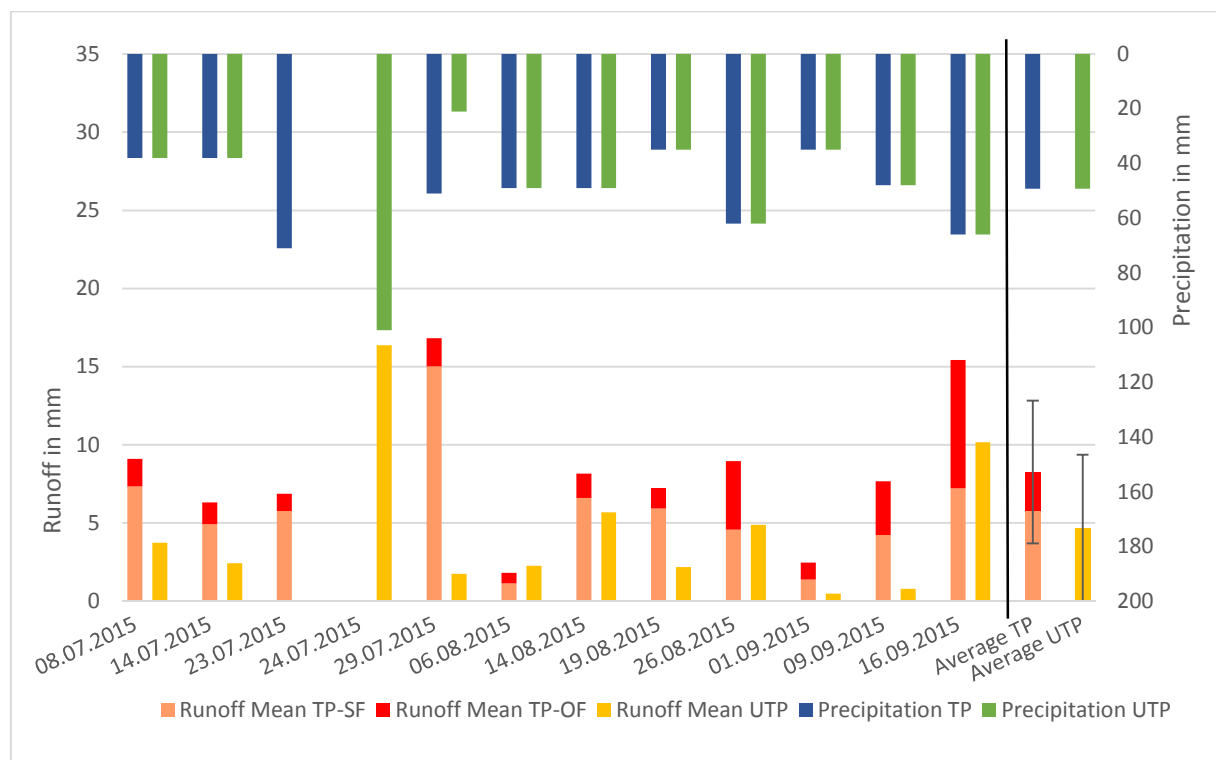
Figure 5-3: Mean runoff values (mean between TP 1 & TP 2 and UTP 1 & UTP 2) for the treated plots (SF= sideflow and OF= overflow) and the untreated plots in comparison to the corresponding precipitation; additional on the right hand side: average runoff and precipitation values (average of all samplings) for the TP and UTP including +/- standard deviation of the runoff

The maximum mean runoff values of 16.4 mm at the UTP and 16.8 mm at the TP were detected on 24th and 29th of July respectively. On 23th of July a very heavy and intense (observed on the field) rainfall event took place and interrupted the 3rd sampling after the treated plots. Therefore, on 24th of July only the untreated plots were sampled and a total of 101 mm of rainfall was recorded. This event led to a very high runoff as seen in Figure 5-3. The treated plots were next sampled on the 29th of July and also in this case high runoff could be measured, although the rainfall sum was since the last sampling only 51 mm. This heavy event from 23rd of July had obviously great influence on the runoff values (see red ellipses in Table 5-2).

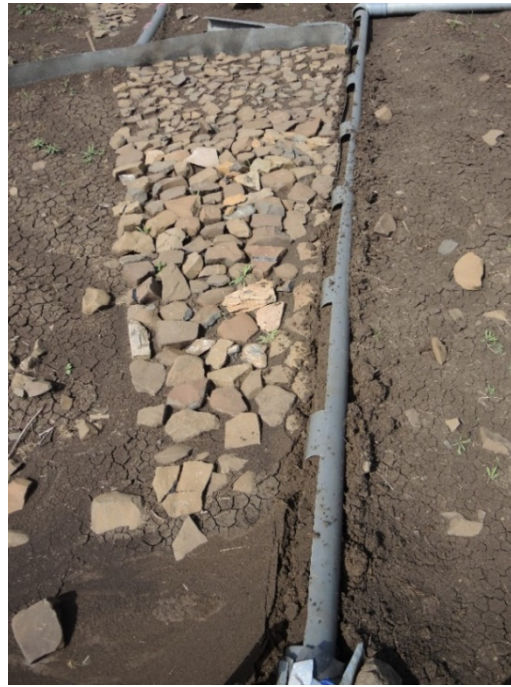
Figure 5-4: Blocked collection pipe at the UTP 1 (photo: S. Wakolbinger)

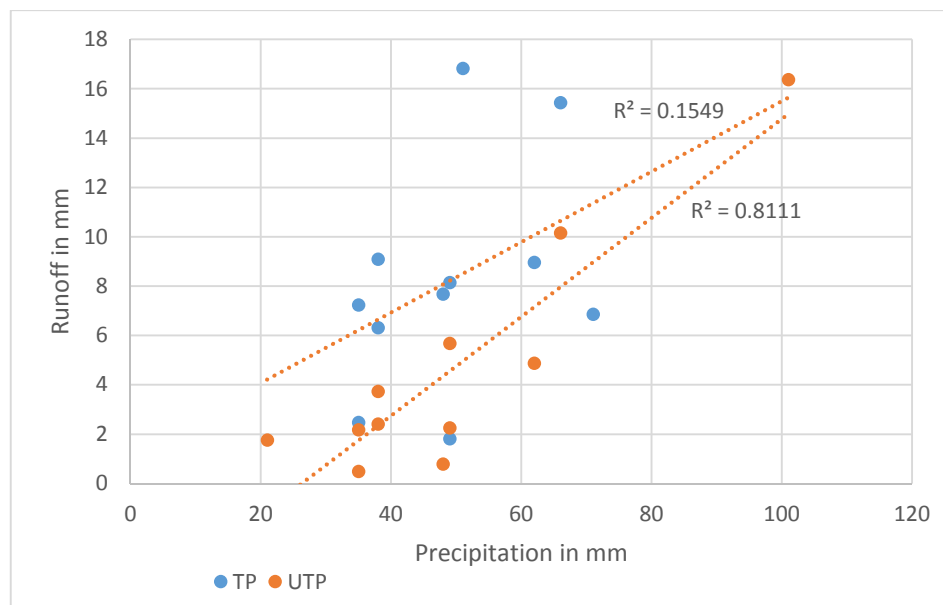
Figure 5-5: Correlation between precipitation values and mean runoff values in mm of the TP= treated plots and the UTP= untreated plots

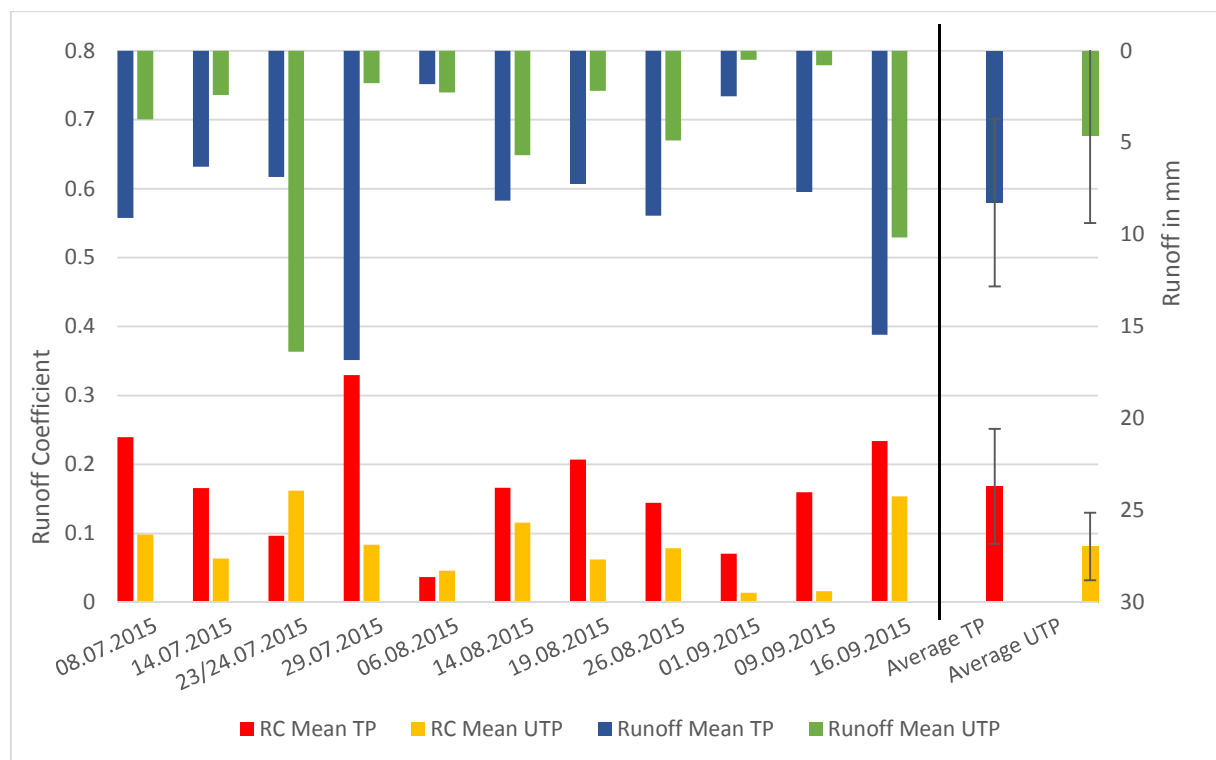
Figure 5-6: Mean runoff coefficient values (mean between TP 1 & TP 2 and UTP 1 & UTP 2) for the treated plots and the untreated plots in comparison to the corresponding runoff values; additional on the right hand side: average runoff coefficient and runoff values (average of all samplings) for the TP and UTP including +/- standard deviation

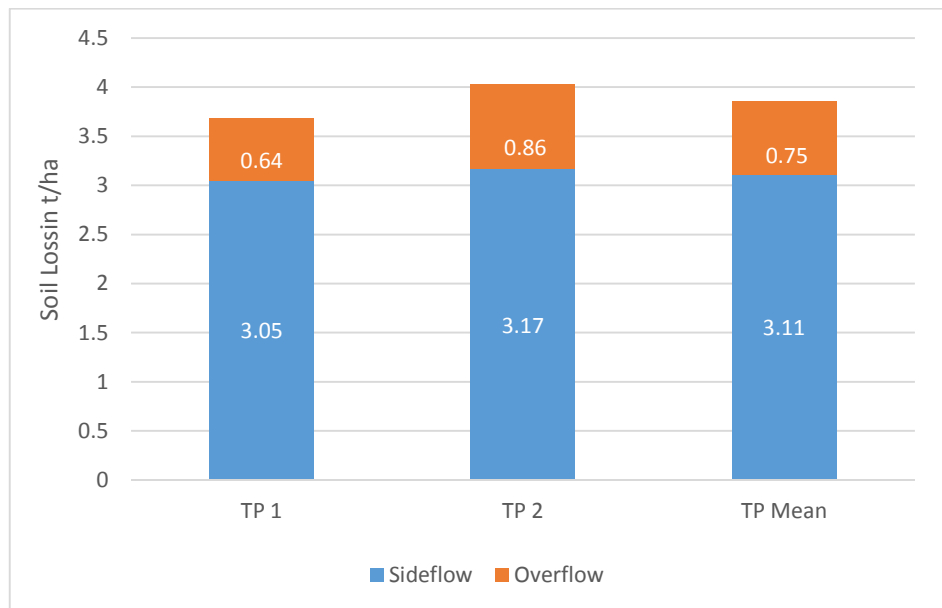
Figure 5-10: Total values of soil loss (side- and overflow) of the TP 1 and TP 2, including the mean value of the treated plots

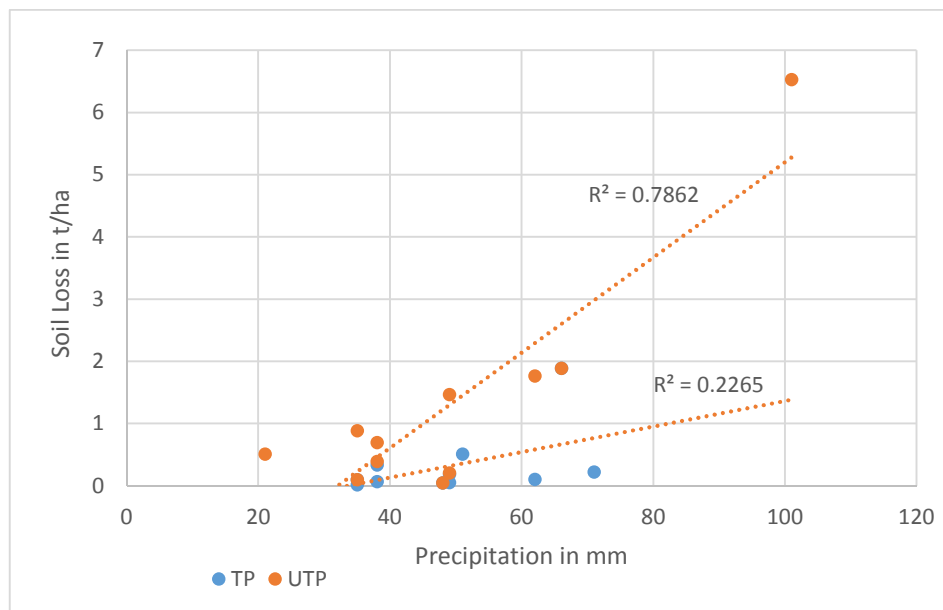
Figure 5-13: Correlation between the precipitation values and the mean soil loss values of the TP= treated plots and UTP= untreated plots

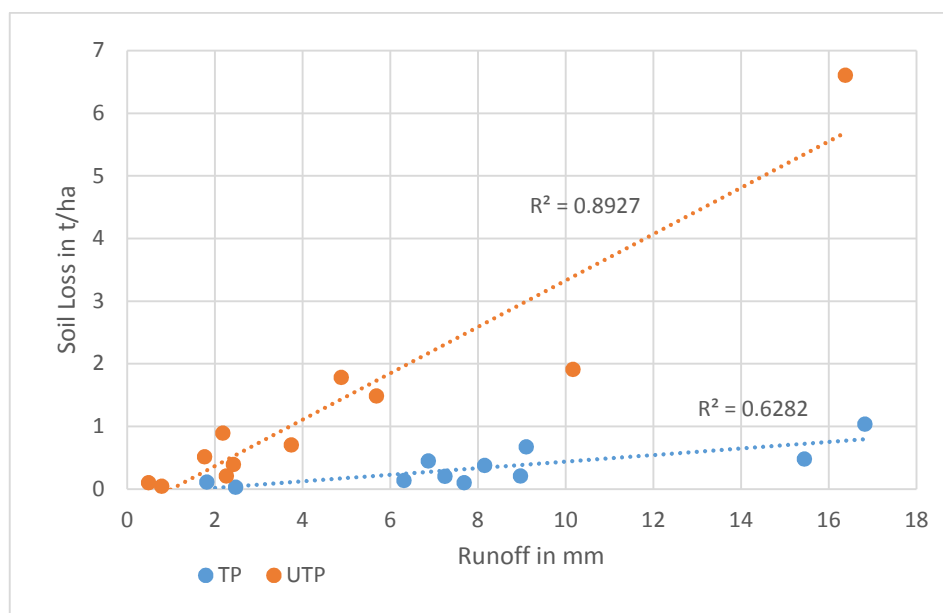
Figure 5-15: Correlation between the mean soil loss values and the mean runoff values of the TP= treated plots and UTP= untreated plots

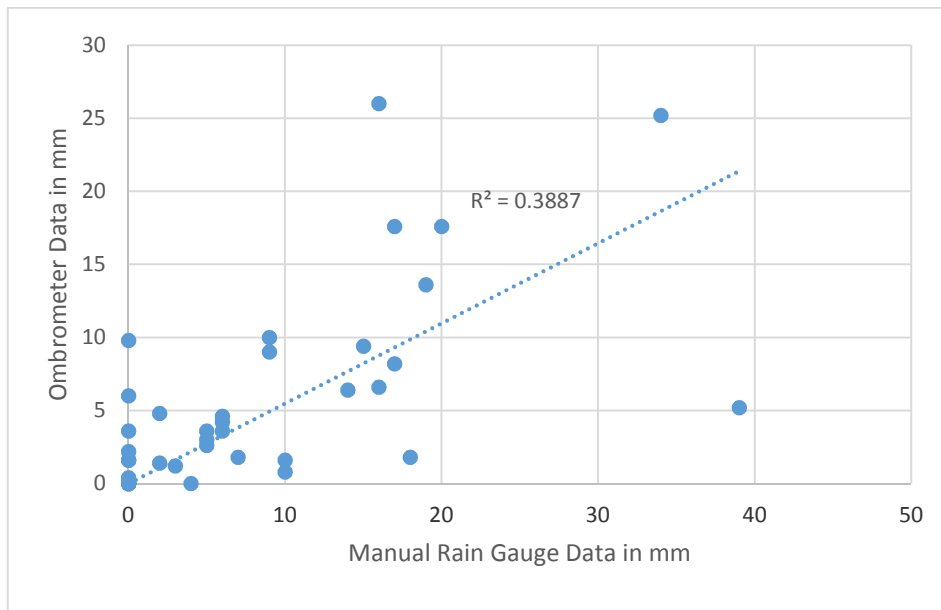
Figure 5-18: Correlation between the daily precipitation data of the manual rain gauge and the automatic tipping bucket ombrometer

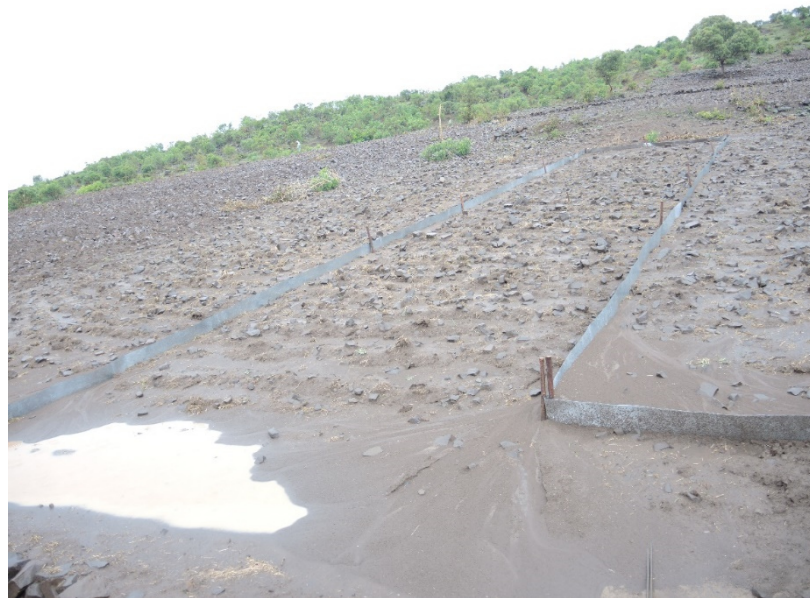
Figure 5-23: Visible soil loss and soil accumulation processes along the stone bund (photo: E. Obereder)

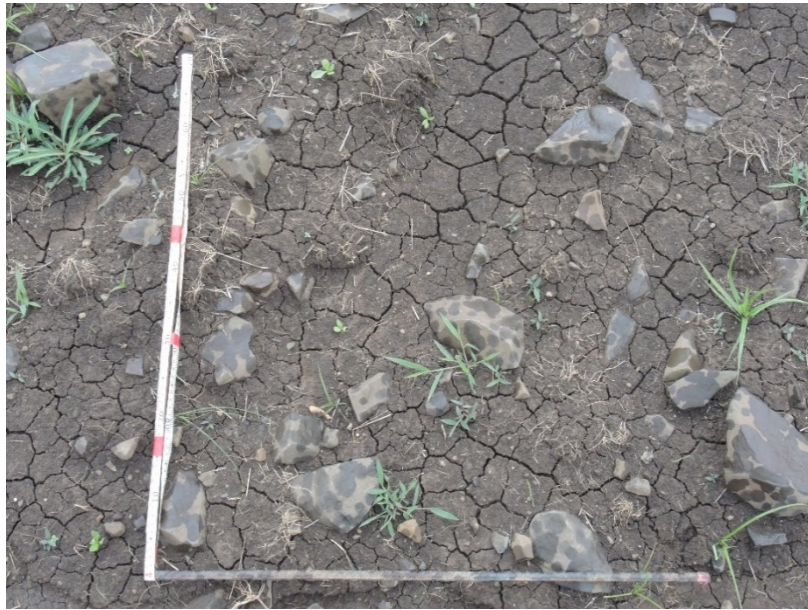
Figure 5-27: Dark spots on the stones after rainfall (photo: E. Obereder)

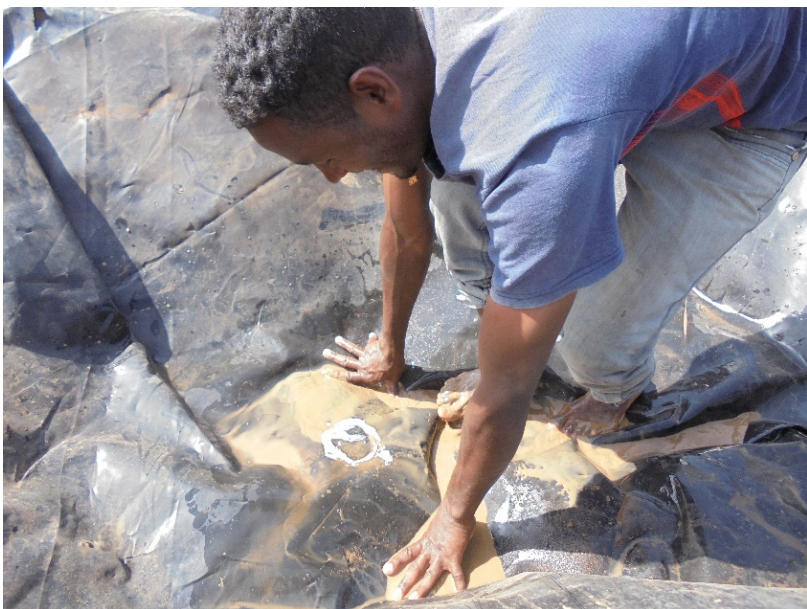
Figure A.1-1.1: Hole in plastic foil at TP 1 – SF (photo: E.Obereder)

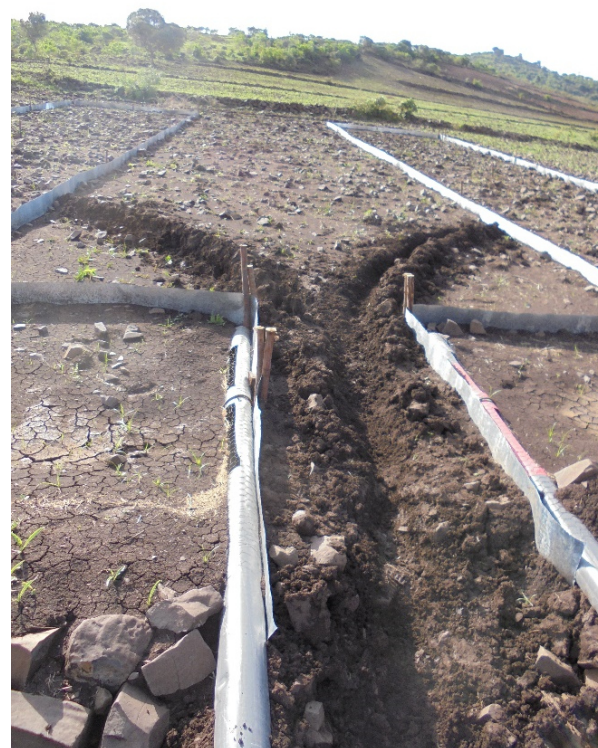
Figure A.1-1.2: Spillways to divert the surface runoff (photo: E.Obereder)

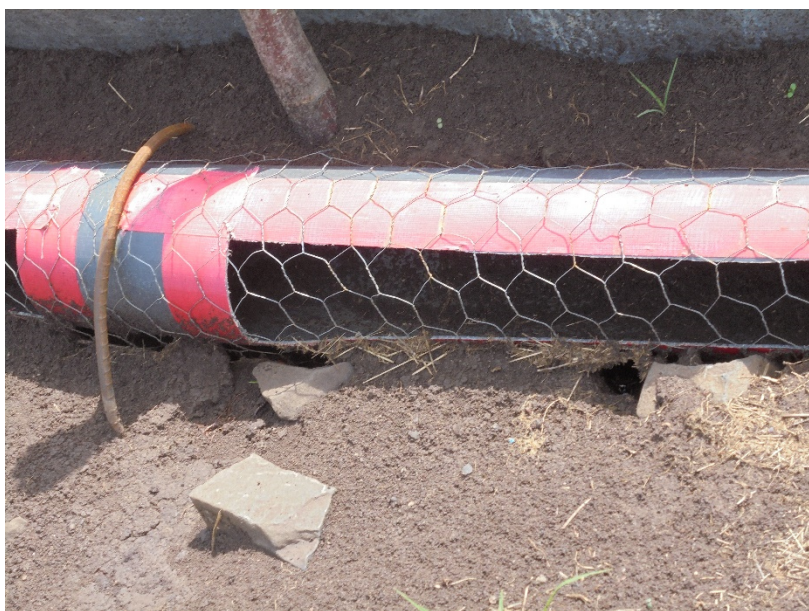
Figure A.1-2.1: Holes underneath the collection pipe (photo: E.Obereder)

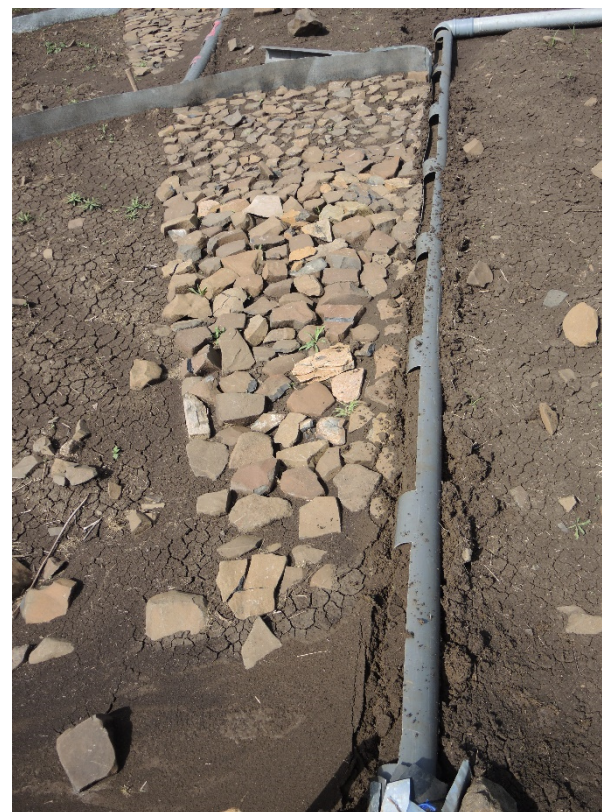
Figure A.1-2.2: Blocked pipe at UTP 1 (photo: E.Obereder)

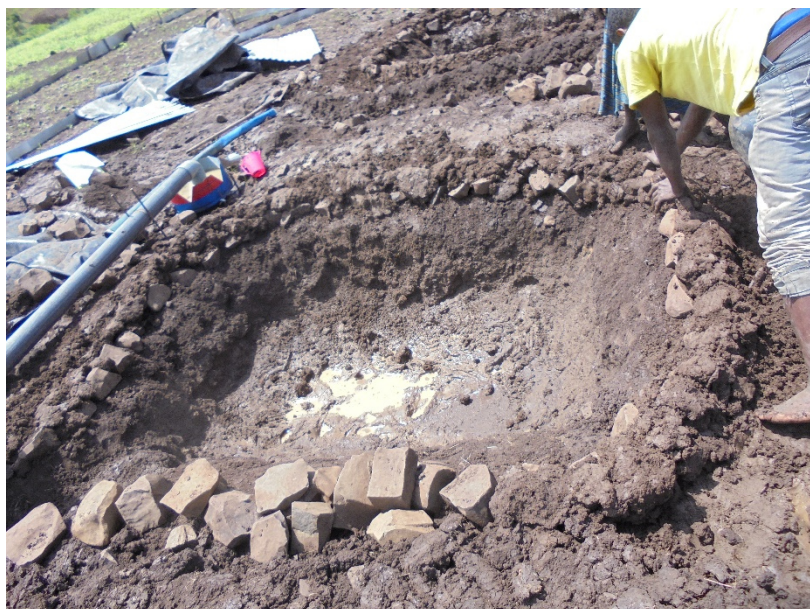
Figure A.1-3.1: Enlargement of the surrounding of the pond (photo: E.Obereder)

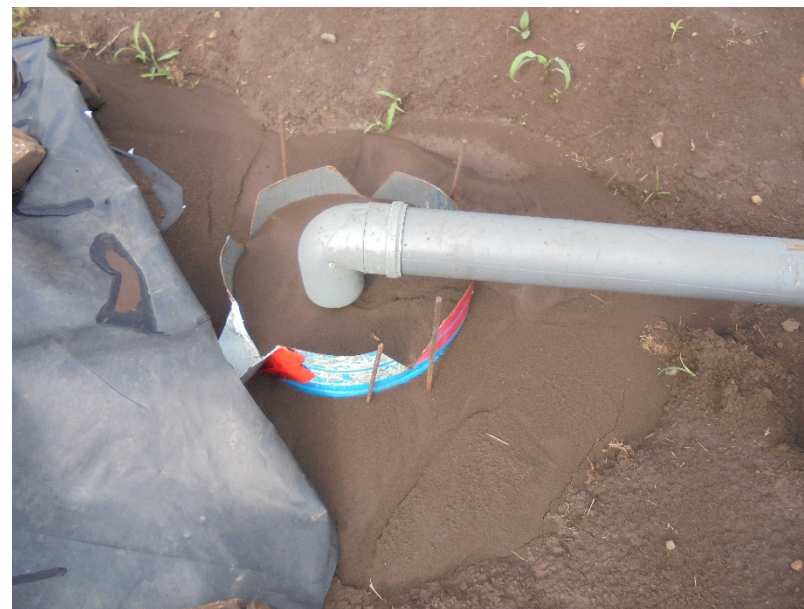
Figure A.1-3.2: Sedimented sample divider and surrounding area (photo: E.Obereder)

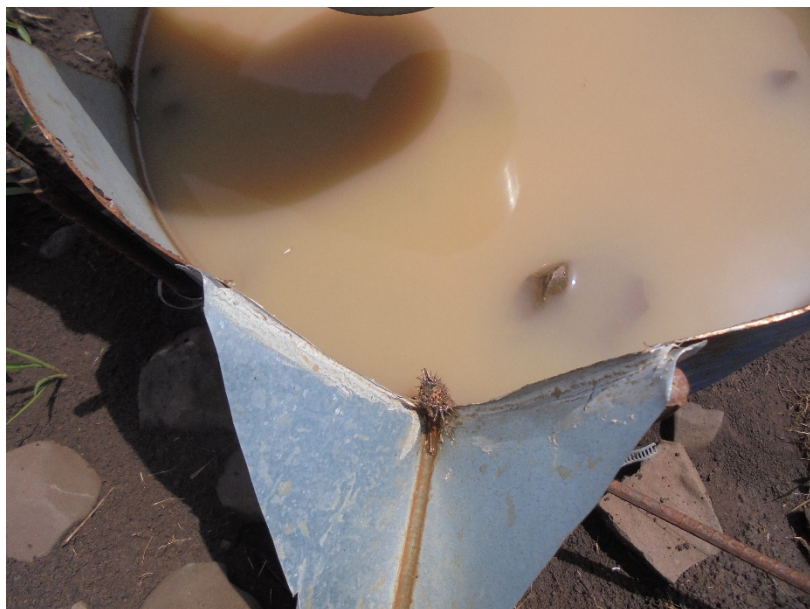
Figure A.1-6.1: Blocked sample divider cut (photo: E.Obereder)

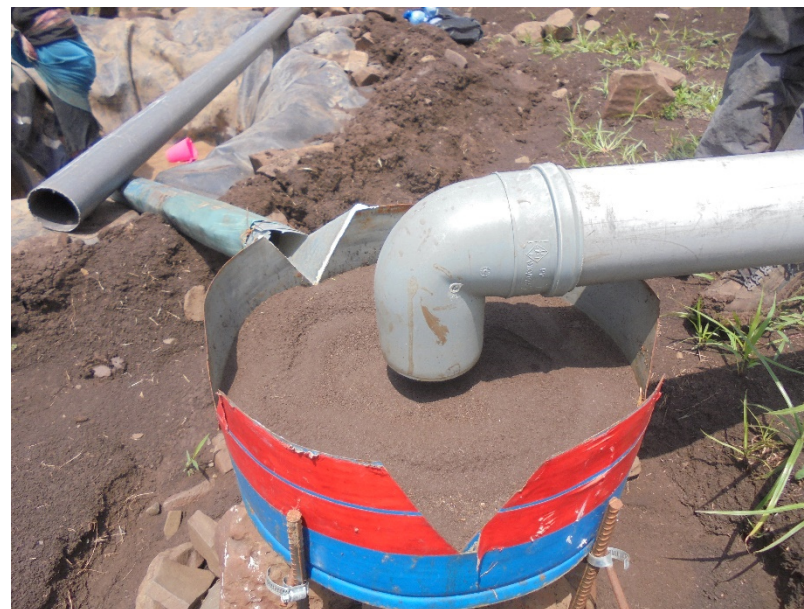
Figure A.1-6.2: Sedimented sample divider (photo: E.Obereder)
